CD00116 Vasse Diversion Drain Upgrade Project

Targeted *Caladenia procera* survey

Prepared for Water Corporation

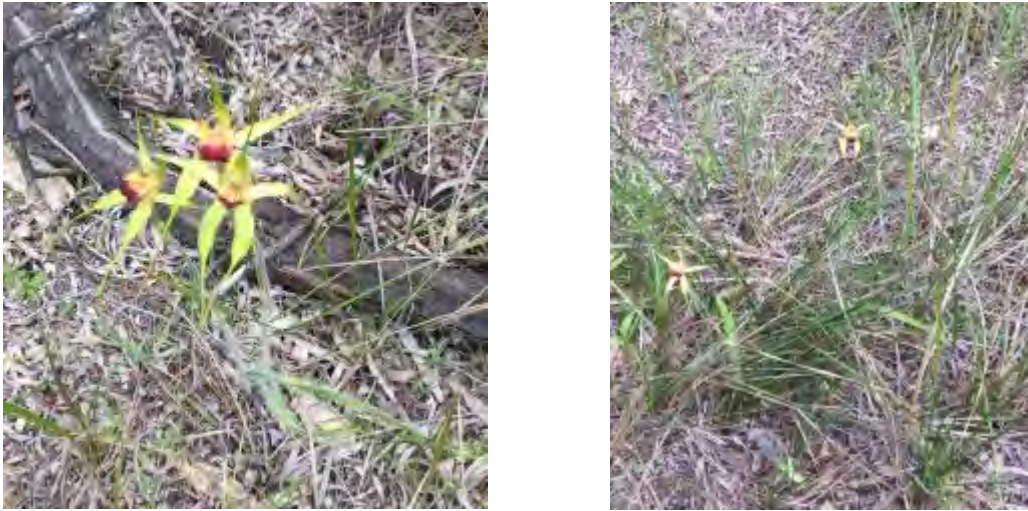
Plate 1: *Caladenia procera* specimens in bloom, taken Monday 14 September 2020, Busselton. (Photo credit: K. Allsopp)

The flowers are c. 5-9 cm across and appear in groups of 1-4 on a scape 35-70 cm tall. The stiffly-held petals and sepals of the flowers are greenish lemon yellow with lines and spots of dull maroon to pink. The labellum is also greenish yellow with pale pink to fawn radiating stripes, ending in a dark maroon recurved tip (Department of Environment and Conservation, 2011).

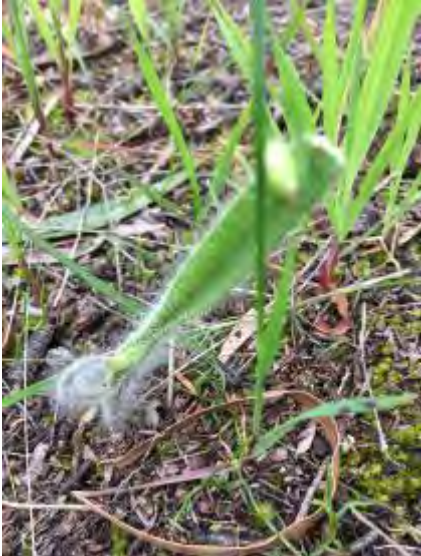
<p>A. Johnston Location identified in EcoEdge, (2019). Unconfirmed location, no photos or flower provided in the report. Note that <i>C. attingens</i> was also positively identified in this location.</p> <p>2020 comments: Same location Identified by K. Allsopp on 14 August 2020. Leaf has been chewed. Flowering stem present.</p>
14 September 2020 Reference Site

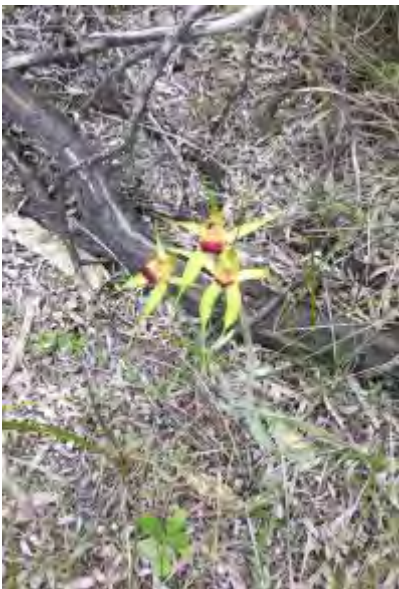
<p>K. Dixon K. Allsopp A. Johnston</p> <p>Reference Site. Multiple locations. Many flowering specimens present.</p>

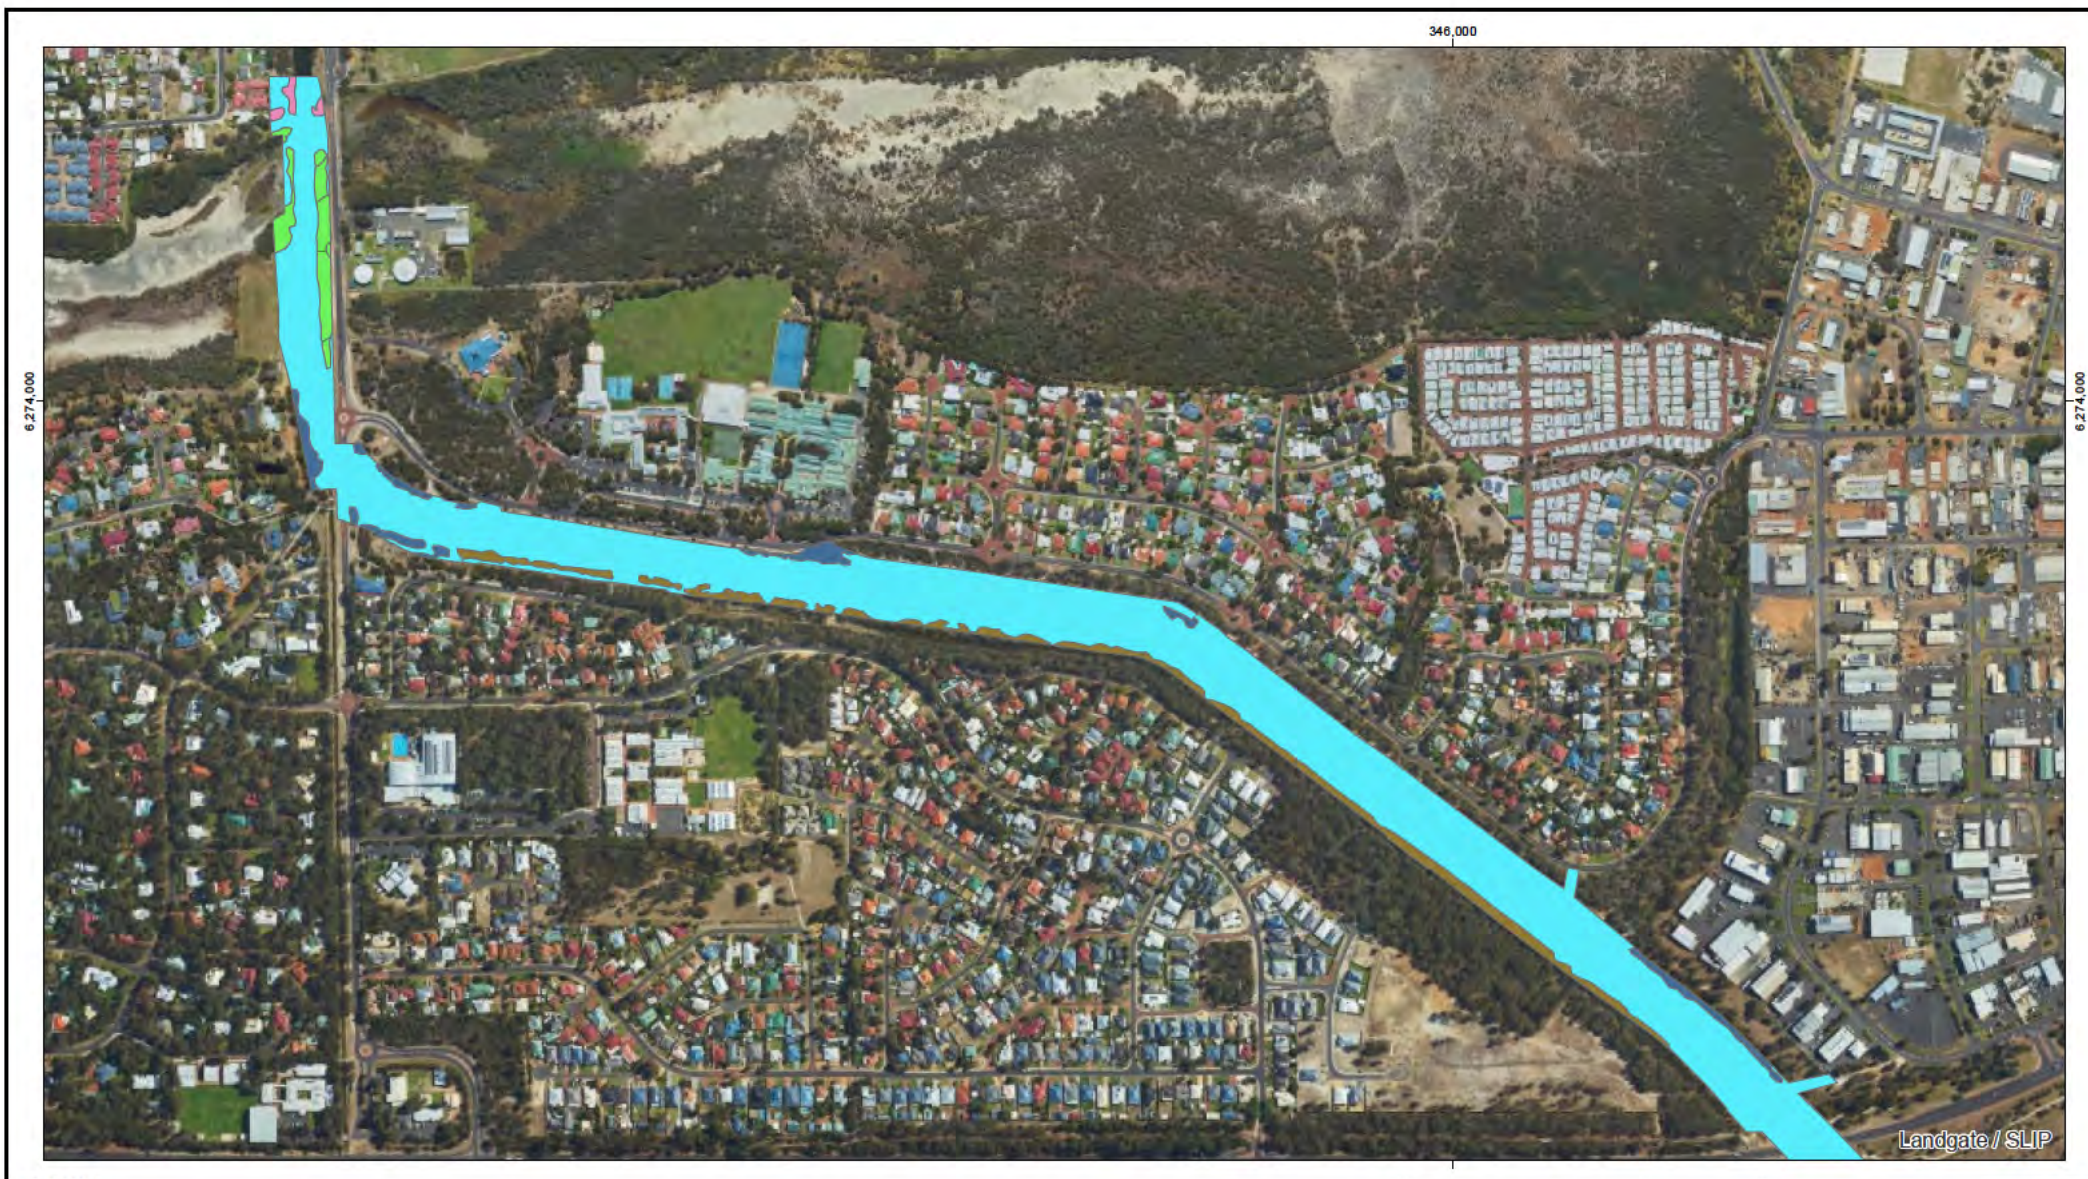
Figure No 2

Multiple flora and vegetation surveys conducted over the last 10 years (see Section 2.2, Figure 2 and Figure 3), most recently in 2019 describe the following vegetation units and condition in the survey area (EcoEdge 2019):

- *Corymbia calophylla* and *Agonis flexuosa* with occasional *Banksia littoralis* and *Melaleuca raphiophylla* mid open forest over *Acacia cochlearis*, *A. saligna*, *Hibbertia cuneiformis* *Jacksonia furcellata*, *Kunzea glabrescens* and *Spyridium globulosum* open shrubland over *Adenanthos meisneri*, *Conospermum caeruleum*, *Daviesia physodes*, *Hardenbergia comptoniana*, *Hibbertia hypericoides*, *Leucopogon propinquus* low shrubland over *Lepidosperma squamatum* and *Tetraria octandra* sedgeland and *Caesia micrantha*, *Chamaescilla corymbosa*, *Conostylis aculeata* subsp. *gracilis*, *Opercularia hispidula*, *Sowerbaea laxiflora*, **Sparaxis bulbifera*, **Watsonia meriana* var. *bulbillifera* and **Zantedeschia aethiopica* mid forbland on dark brown sandy loams. ('*Eucalyptus rudis*, *Corymbia calophylla* and *Agonis flexuosa* Closed Low Forest' PEC). (Degraded-Good)

- *Agonis flexuosa* low woodland and scattered *Acacia saligna* or *A. cochlearis* tall shrubs over **Ehrharta longifolia*, **Watsonia meriana* and other introduced herbaceous species (mainly Completely Degraded)
- *Melaleuca cuticularis*, *M. lanceolata* and *M. raphiophylla* tall open shrubland over *Gahnia trifida* and *Baumea juncea* sedgeland (Good-Very Good) (Part of Conservation category wetland)
- *Agonis flexuosa* woodland over *Acacia littorea*, *Olearia axillaris* and *Spyridium globulosum* tall open shrubland over *Lepidosperma gladiatum* sedgeland (Good-Very Good)
- **Eragrostis curvula*, **Cenchrus clandestinus* grassland, scattered *Acacia saligna* shrubs, bare areas and watercourse (Completely Degraded)

CPS8191/1, 2017/7932
CD00116
Vasse Diversion Drain Upgrade
Vegetation Type
EcoEdge 2020

Other areas of clearing proposed for the project were not suitable habitat for the orchid, either being degraded to completely degraded, or unsuitable vegetation soil and hydrological conditions (See **Figure 2** and **Figure 3**).

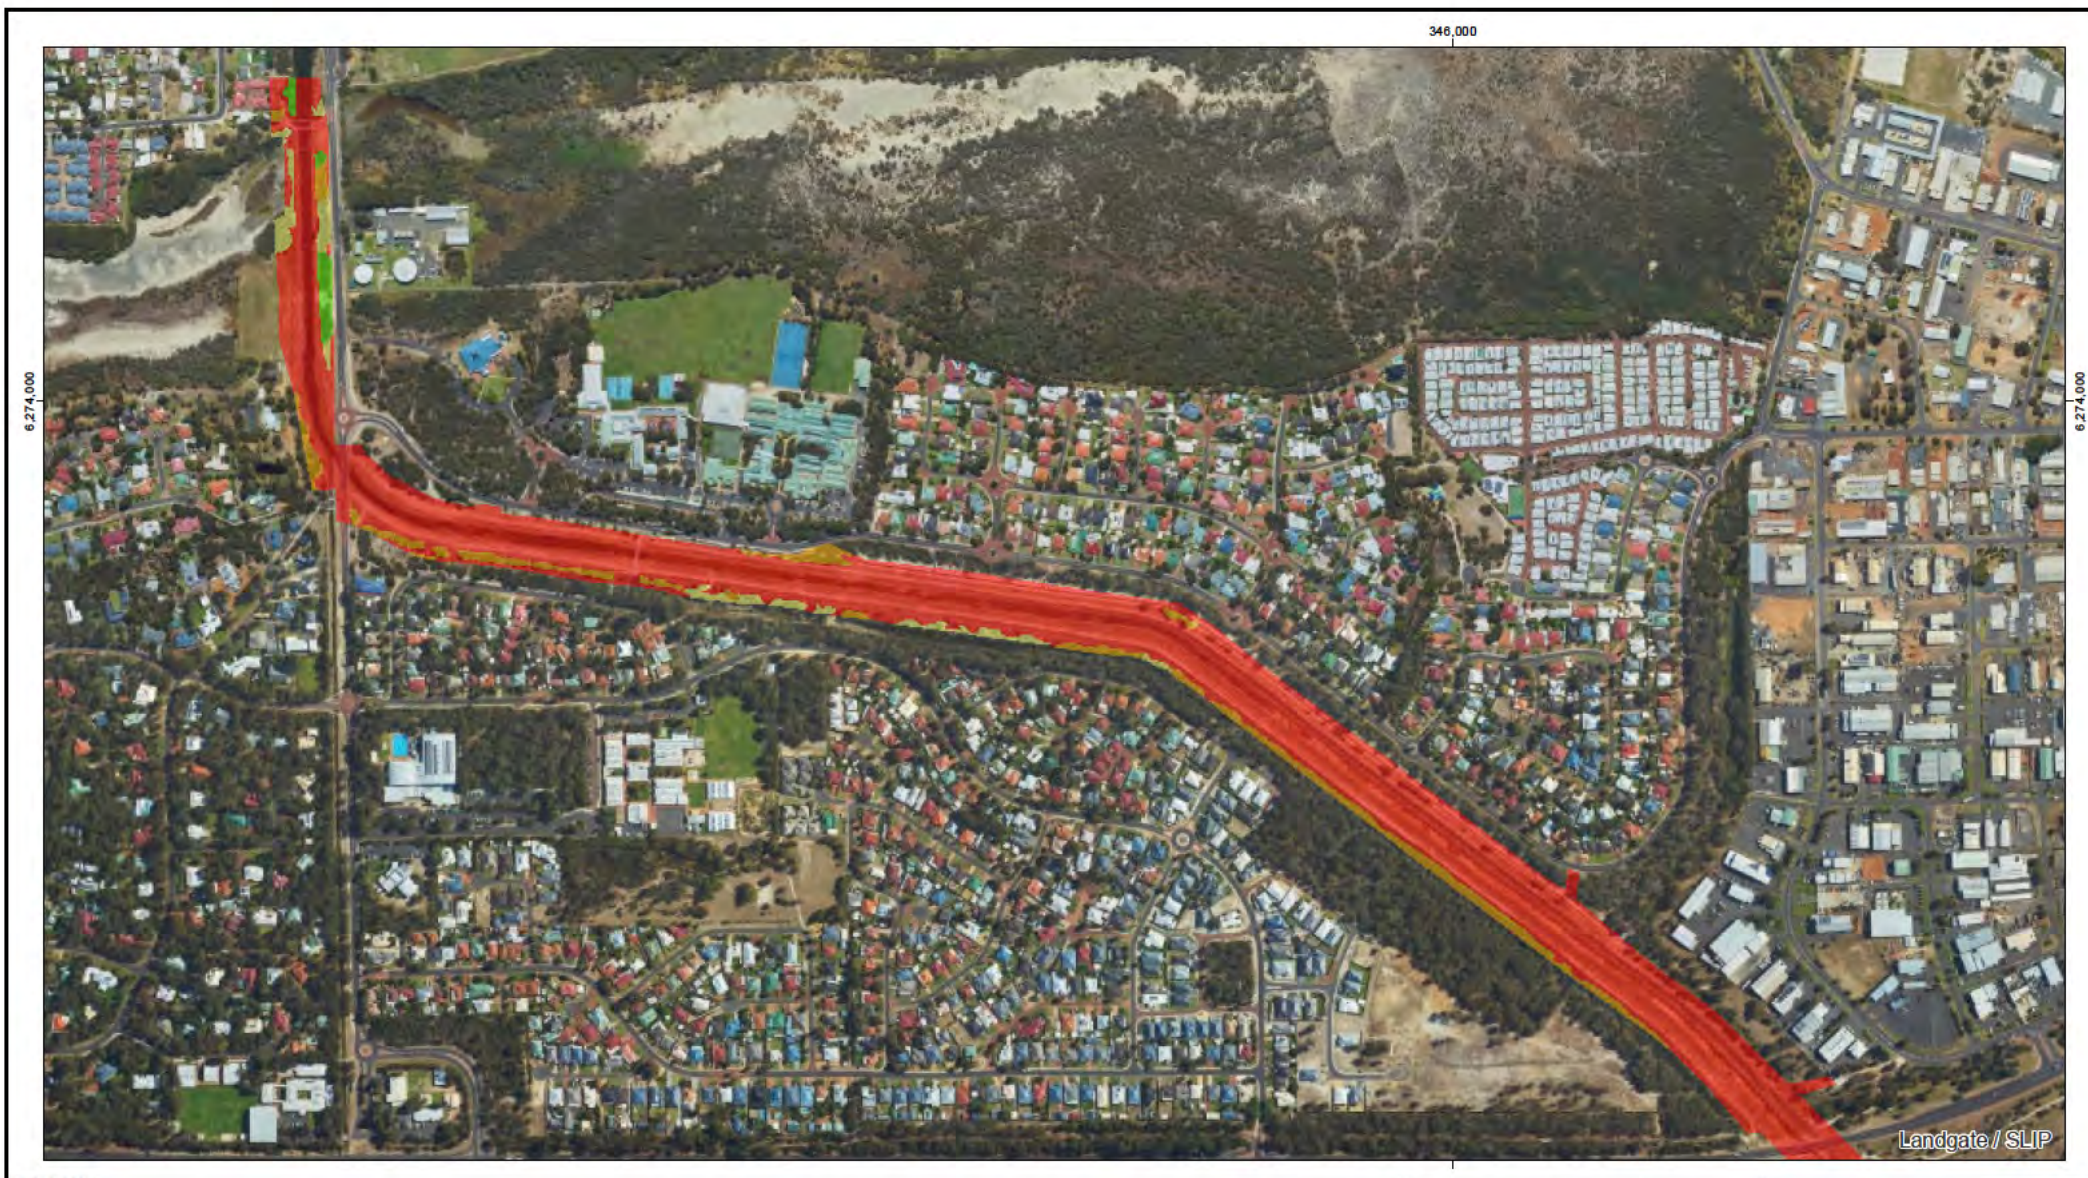
CPS8191/1, 2017/7932
CD00116
Vasse Diversion Drain Upgrade
Vegetation Condition
EcoEdge 2020
