The purpose of this specification is to describe the requirements for chlorine pigtails (copper flexible tubing/piping) used at Water Corporation sites to connect chlorine drums to the chlorine manifold.

The CHLORINE PIGTAIL is a round coiled tube/pipe made from copper alloy with brass alloy end fittings which shall comply with the following requirements;

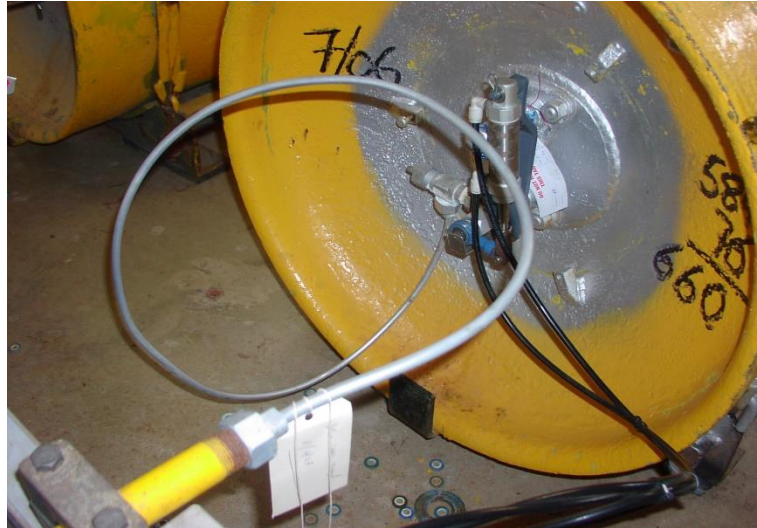
- Supplier certified to AS/NZS ISO 9001:2016
- Copper alloy tube C122 manufactured to AS1572
- Brass alloy end fittings 385 manufactured to AS1567
- Brazing procedure certified to AS/NZS ISO 9001:2016
- Length of 1.8m
- Replaced 12 monthly as a minimum or sooner if a visual inspection suggests that replacement is warranted

- Each pig-tail is fitted with an expansion chamber and rupture disc, designed to allow expansion of any trapped chlorine when a pressure of ~2600kPa is reached (it also takes some time, depending on ambient temperature, for any chlorine trapped to heat up enough to reach ~2600kPa). Pipework and pig-tails in good working order are designed for pressures well in excess of 2600kPa.
