Inspection Guidelines for the Condition Assessment of Concrete and Steel Structures Using Remotely Piloted Aircrafts (RPA's)

(Business Rules)

Water Corporation ABN 28 003 434 917

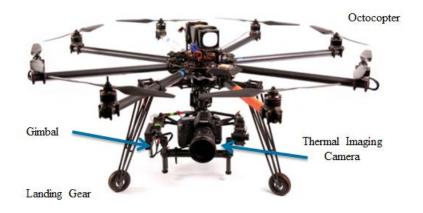
Photo 1 – Various components of RPA.

A Remotely Piloted Aircraft System (RPA), commonly known as an Unmanned Aerial Vehicle or Unpiloted Aerial Vehicle (UAV) or drone, is an aircraft without a human pilot aboard. Its flight is controlled either autonomously by on-board computers or by the remote control of a pilot on the ground or in another vehicle.

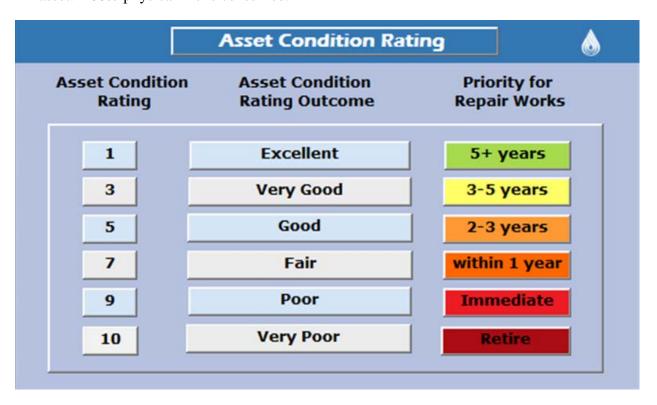
Figure 1 – Asset Condition Rating based on TDST model.

For the condition assessment of tanks, In-Service Assets utilises TDST model [Refer: Figure 1]. The condition rating is based on 1 to 10 scales and the outcome is summarised as below [3].

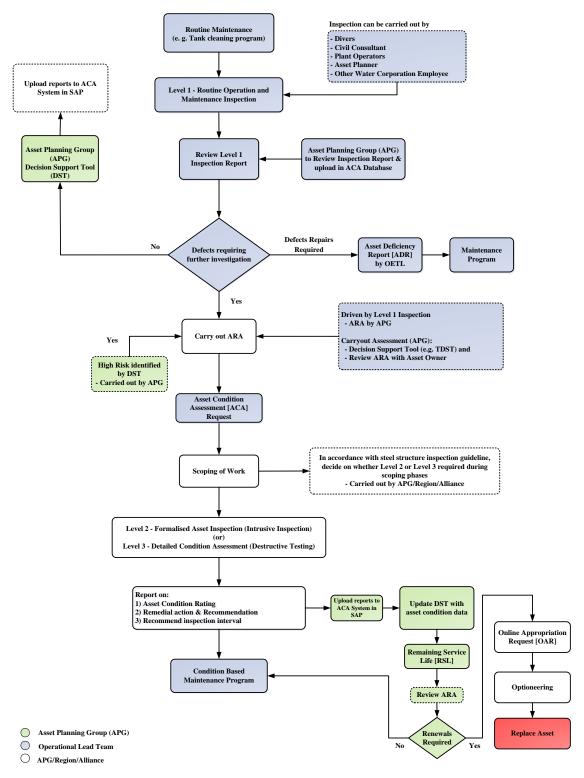
Figure 2 – Overview of Corporation's steel tank ACA process.

For example, an overview of the Corporation's ACA process on steel tanks is shown in **Figure 2**.
