| Doc ID #163240598 | Custodian Manager – Inspection and Condition Assessment |

1 Purpose

The purpose of this document is to enable a non-expert to gain sufficient knowledge to be able to confidently identify the hazardous factory-applied pipe coatings that are commonly encountered by personnel working with Water Corporation assets. Images of a range of pipe examples are presented to illustrate the various ways a pipe coating can appear after many years of service, storage, or neglect.

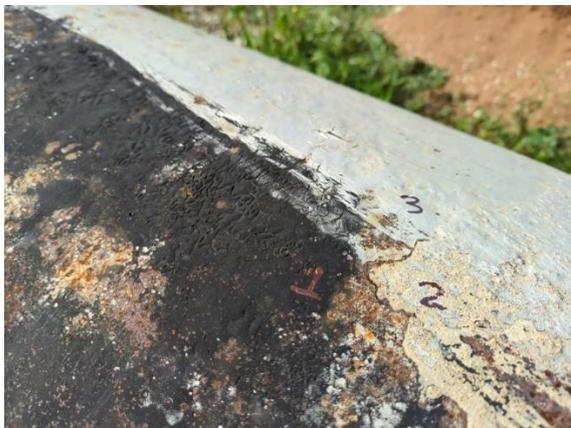
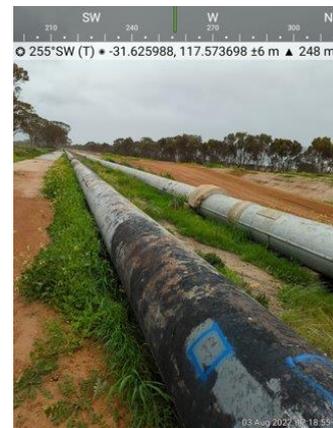
Figure 1 – Decommissioned DN760 locking bar pipe installed above ground near Tammin. This pipe was originally buried but was reinstalled above ground in the 1930s. This example includes various coatings including remnants of the original hot-dipped bitumen coating.

The numbered areas on the image above show:

1. Original hot-dipped bitumen coating.
2. Cement wash applied when the pipe was reinstalled above-ground in the 1930s.
3. Heat reflective paint applied later.

Analysis of a sample of the bituminous material taken from this pipe in 2022 recorded high levels of PAHs.

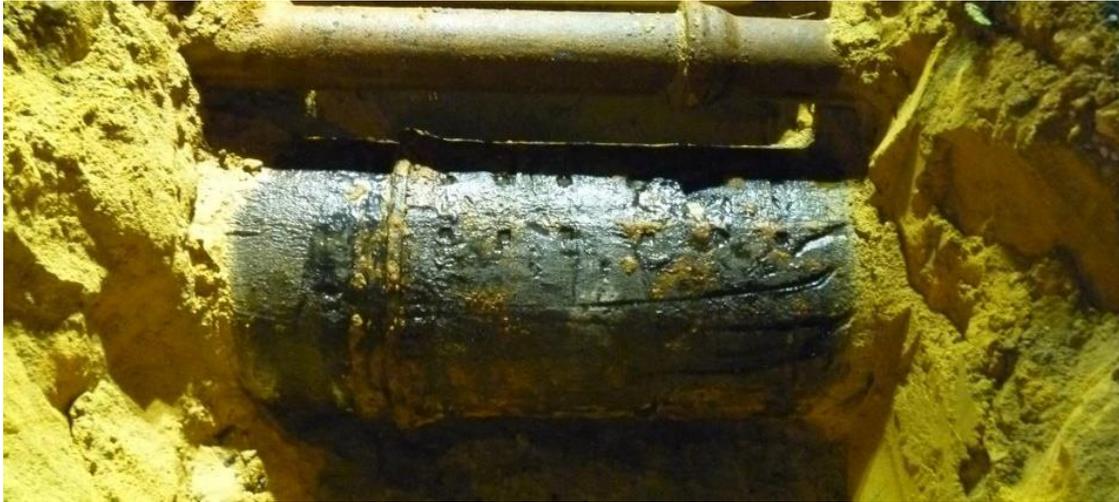
Figure 2 - DN760 pipe with bitumen coating without wrapping fabric installed in Nedlands in 1934.

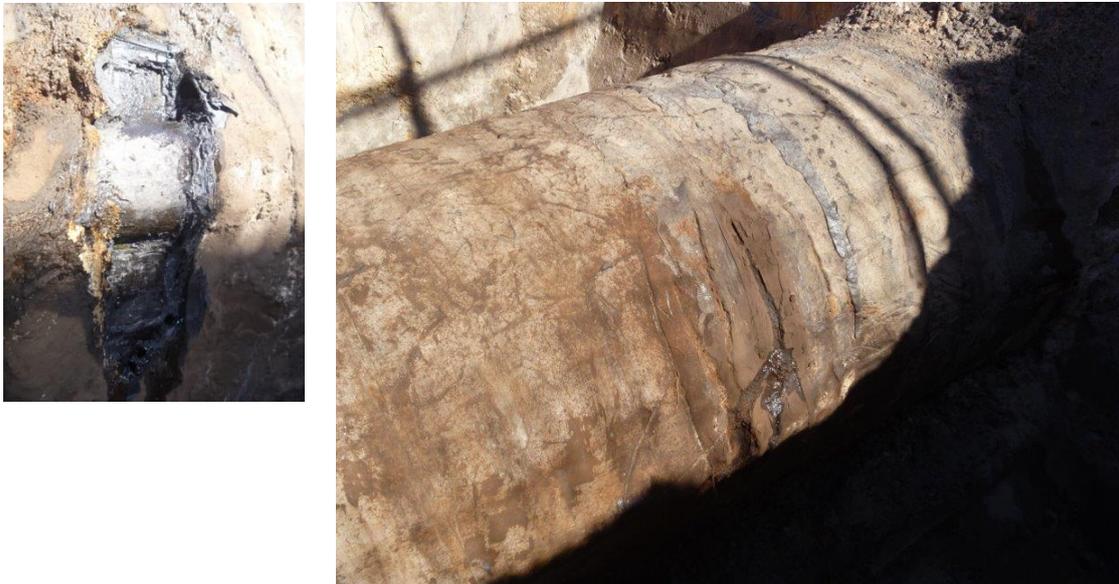
Figure 3 - DN760 locking bar pipe with bitumen coating incorporating non-asbestos hessian fabric. Talbot Road, Mundaring.

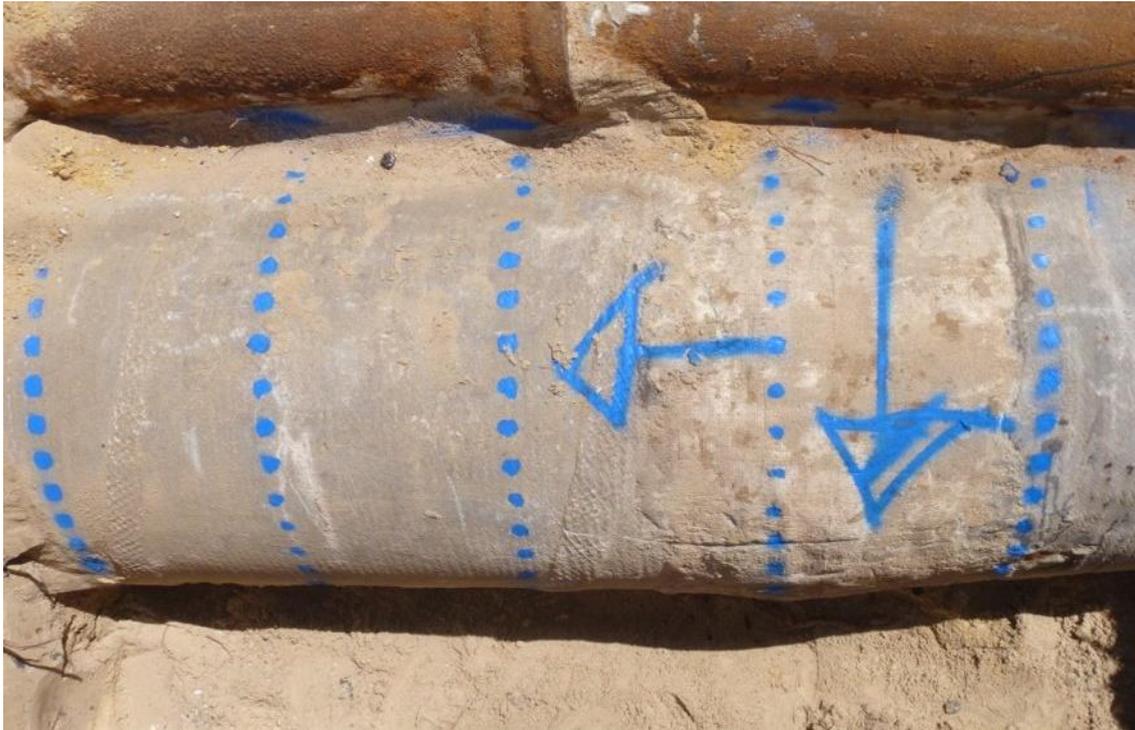
Figure 4 – DN610 MSCL pipe with factory-applied asbestos cement wrap coating (left of image) and field-applied asbestos mortar over the joint (right).

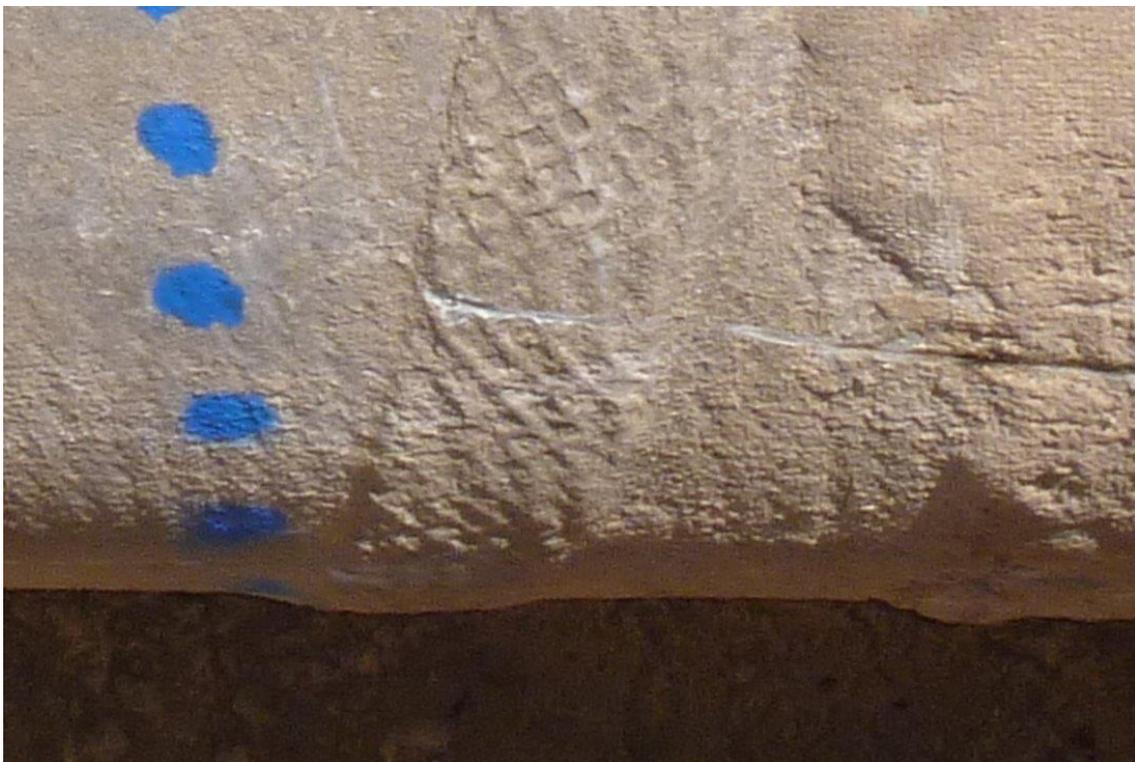
Figure 5 - A closer look of the coarse weave of the asbestos bandage is evident at the overlap; hand-applied asbestos mortar over the field joint is at the right of the image.

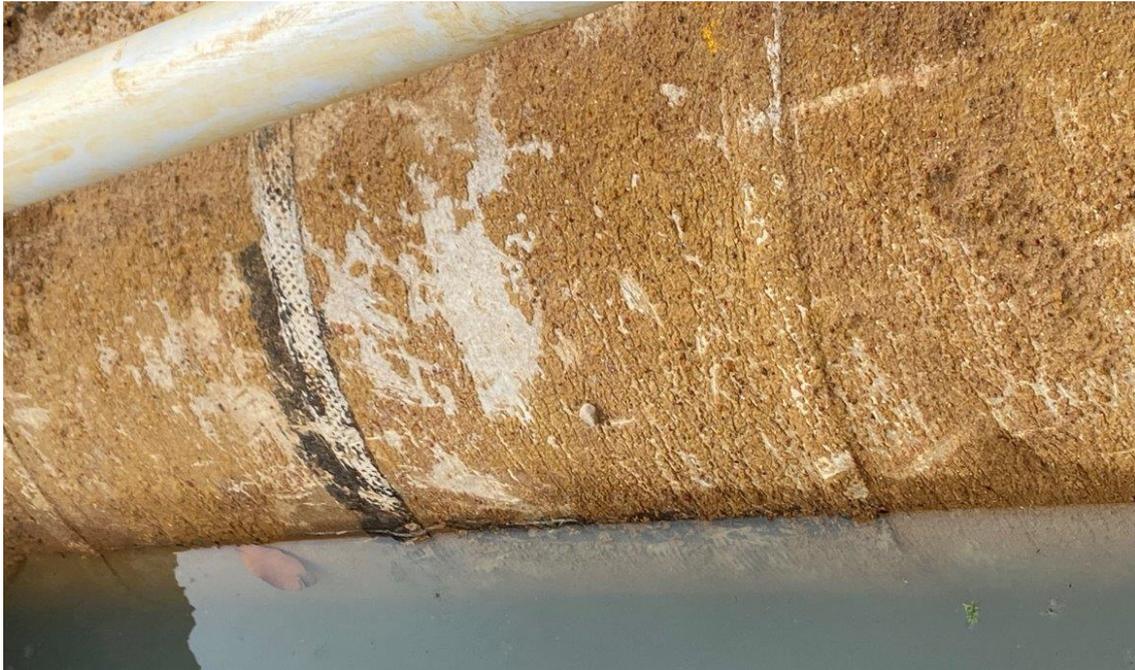
Figure 6 – DN1065 Canning Trunk Main, Albany Hwy, Maddington. Note the coarse weave of the asbestos bandage evident at the overlap of the wrap.

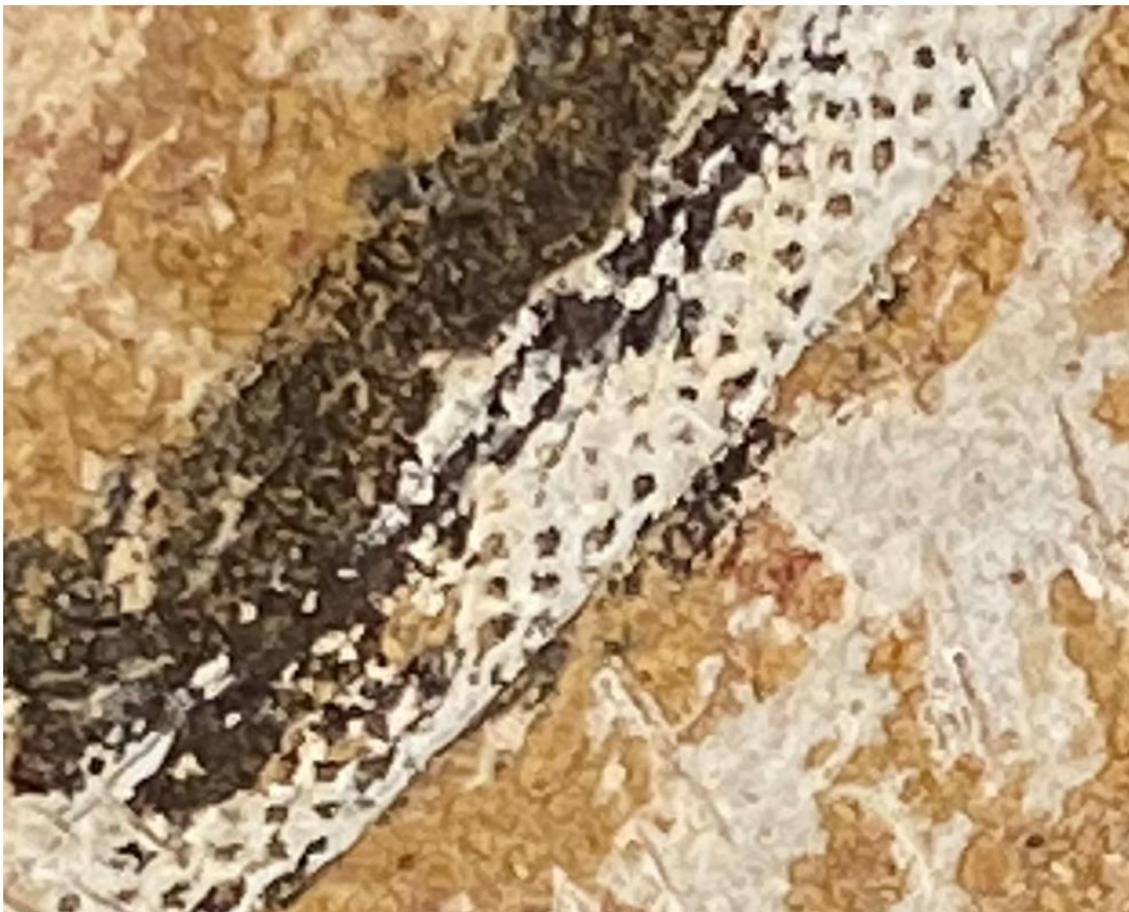
Figure 7 - DN1065 Canning Trunk Main, Albany Hwy, Maddington. Close-up of bandage overlap.

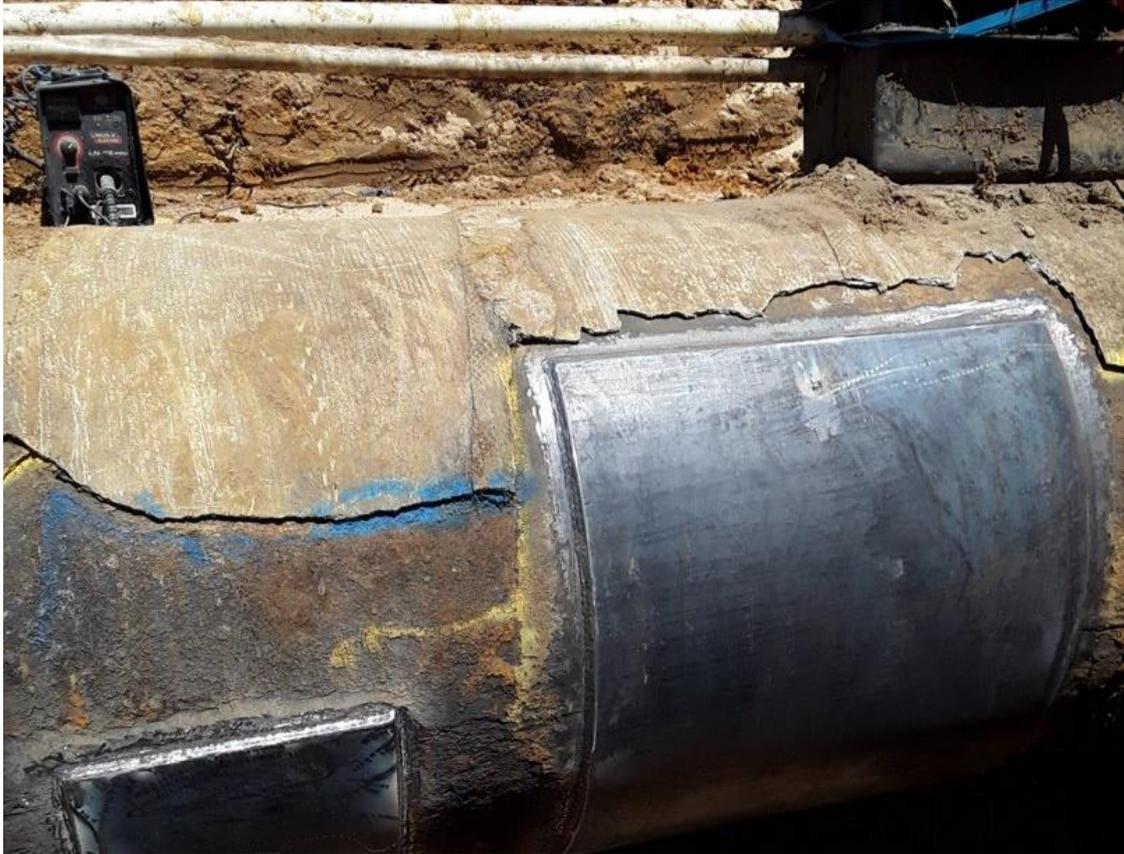
Figure 8 – DN 1065 Canning Trunk Main, Albany Hwy, Maddington. Asbestos cement bandage removed for pipe repair.

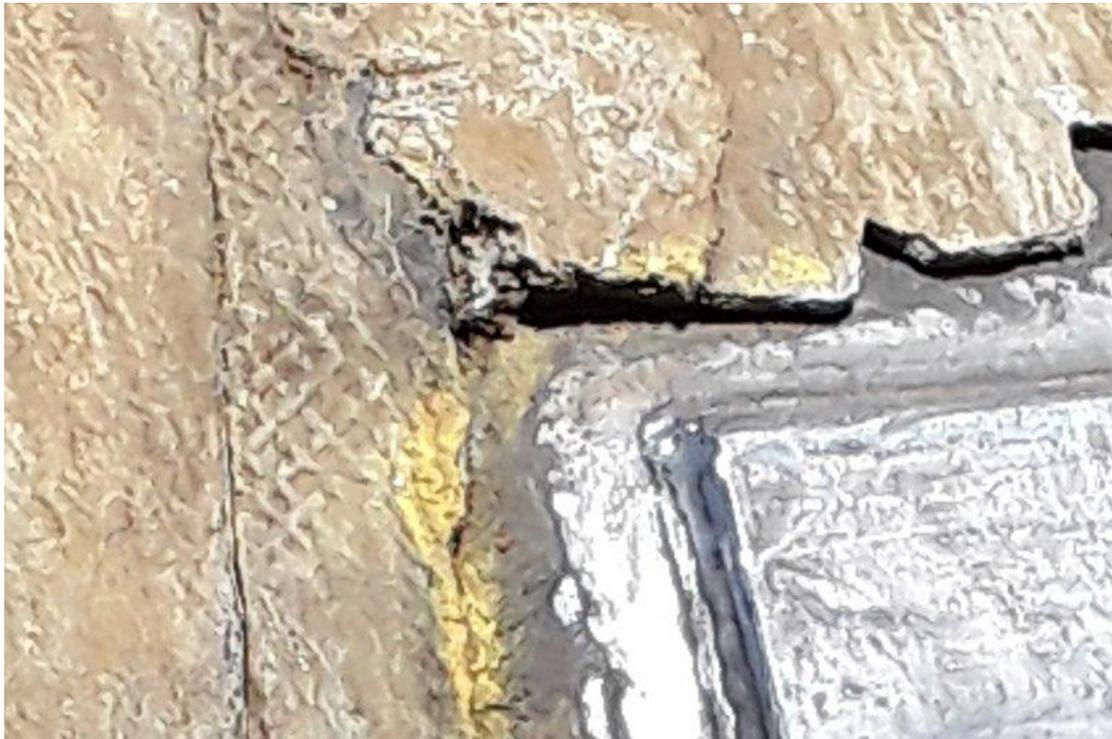
Figure 9 – DN 1065 Canning Trunk Main, Albany Hwy, Maddington. Close-up of asbestos cement bandage

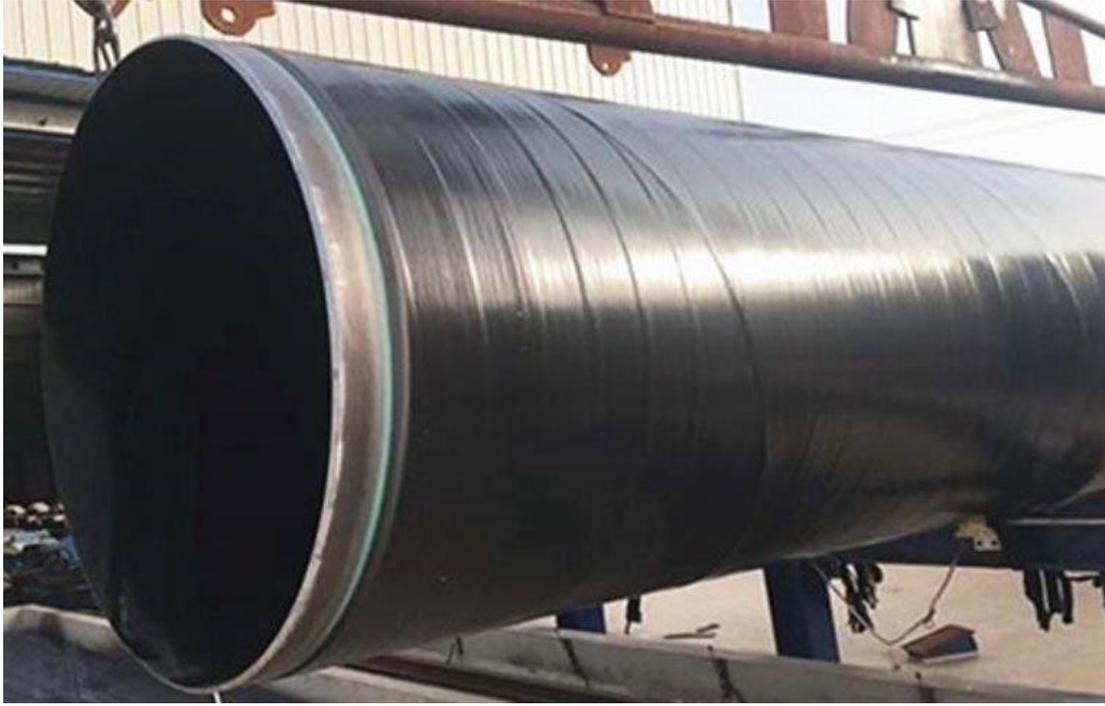
Figure 10 - New coal tar epoxy coating. Note the spiral weld bead of the pipe is evident.

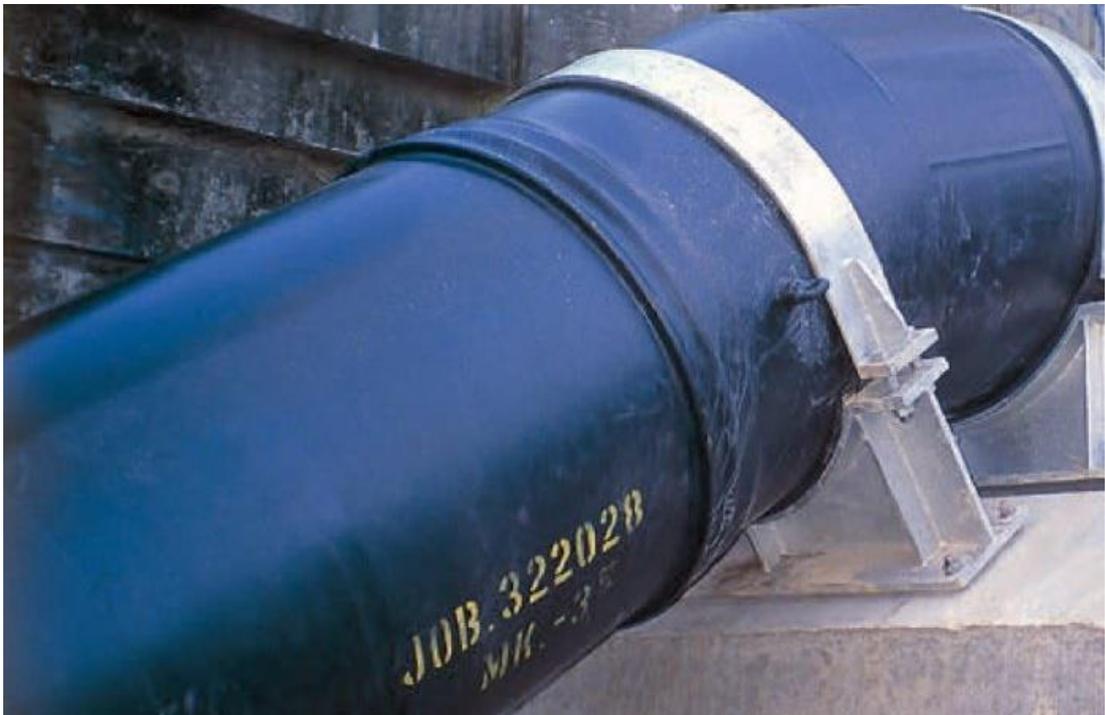
Figure 11 – Near new fusion-bonded polyethylene (Sintakote).

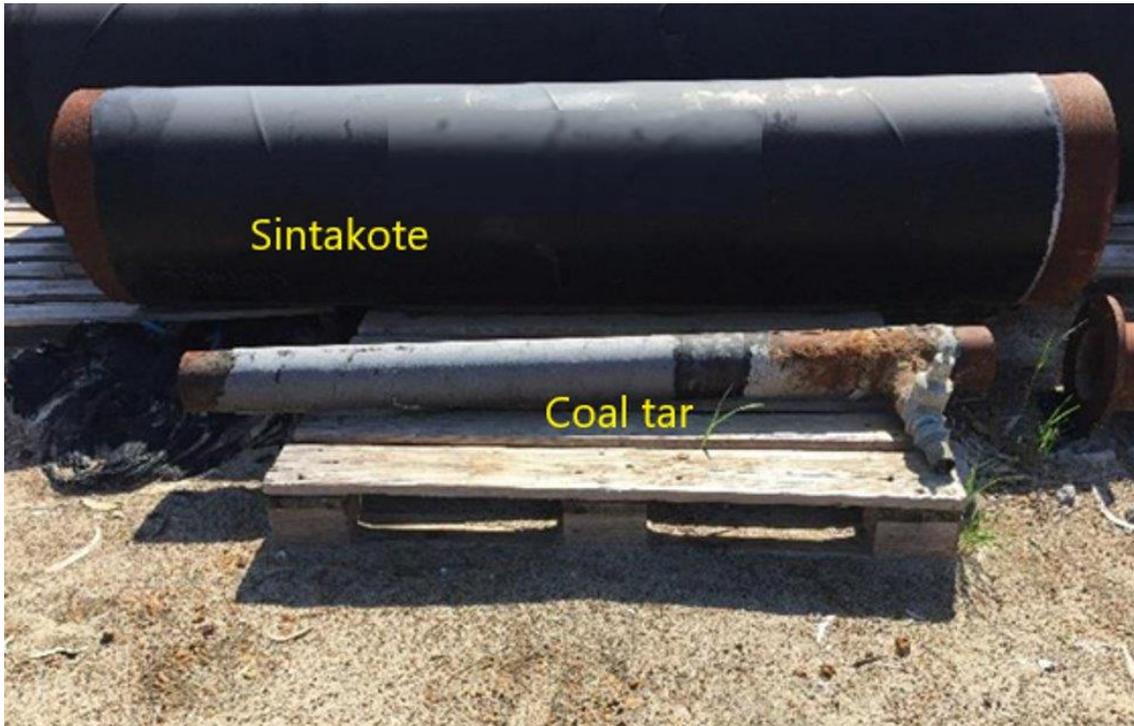
Figure 12 – Compare weathered fusion-bonded coated pipe (background) with weathered CTE-coated pipe (foreground).

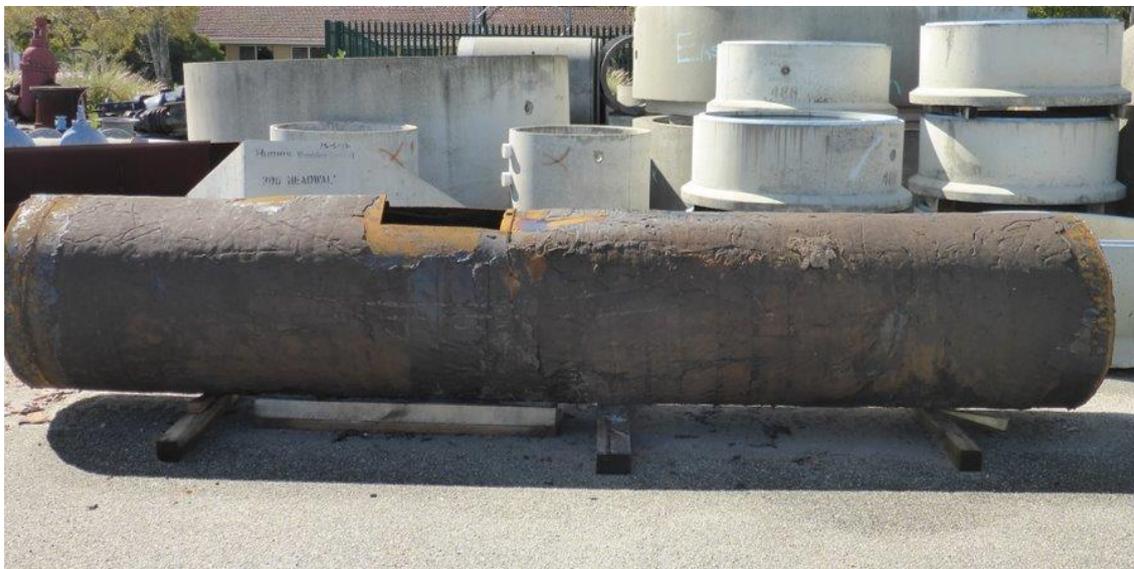
Figure 13 - Exhumed asbestos coal tar coated pipe originally installed in 1952. Note the coating deformation caused by soil stress and tree roots and the spiral wrap of the asbestos bandage.

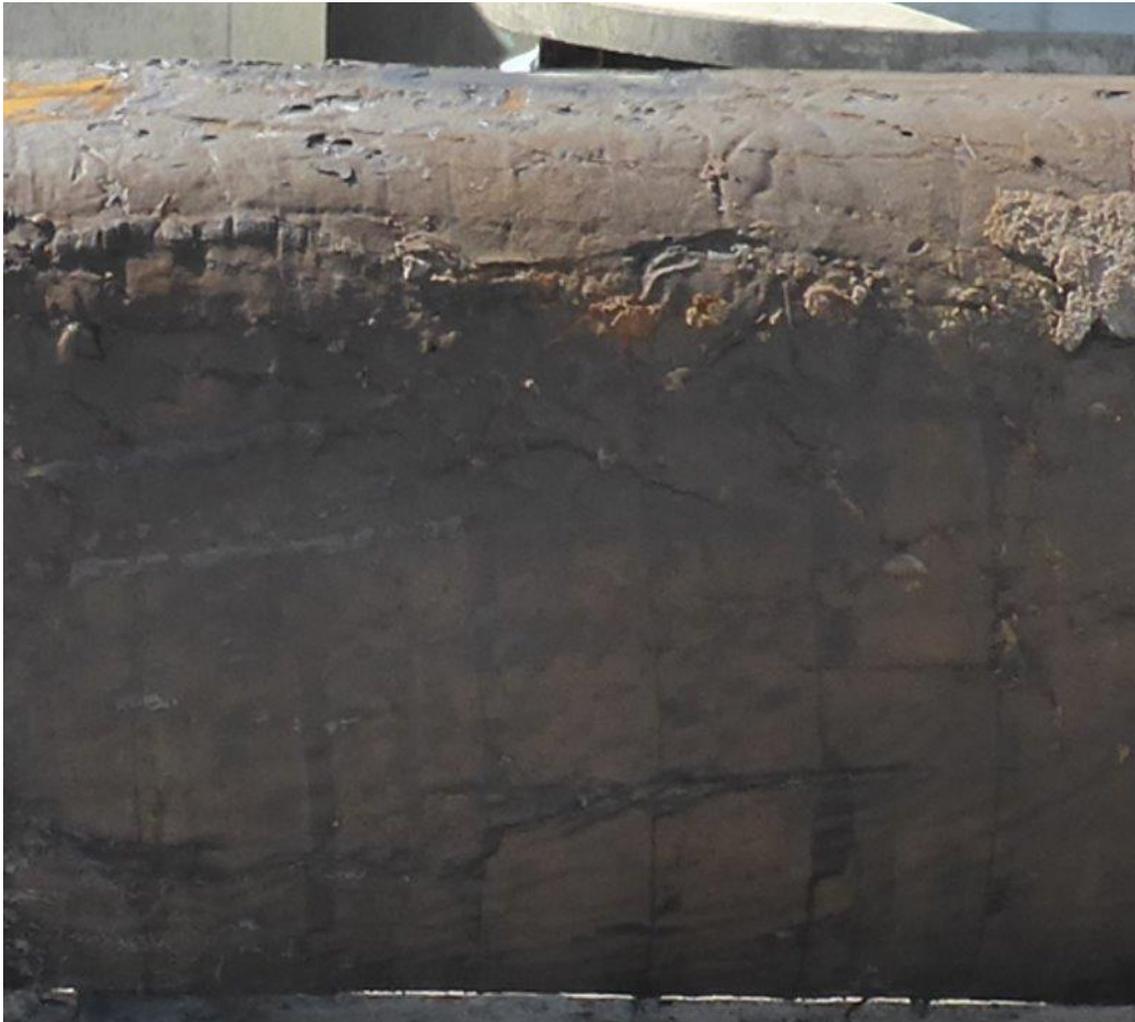
Figure 14 - Exhumed asbestos coal tar coated pipe originally installed in 1952. Close-up

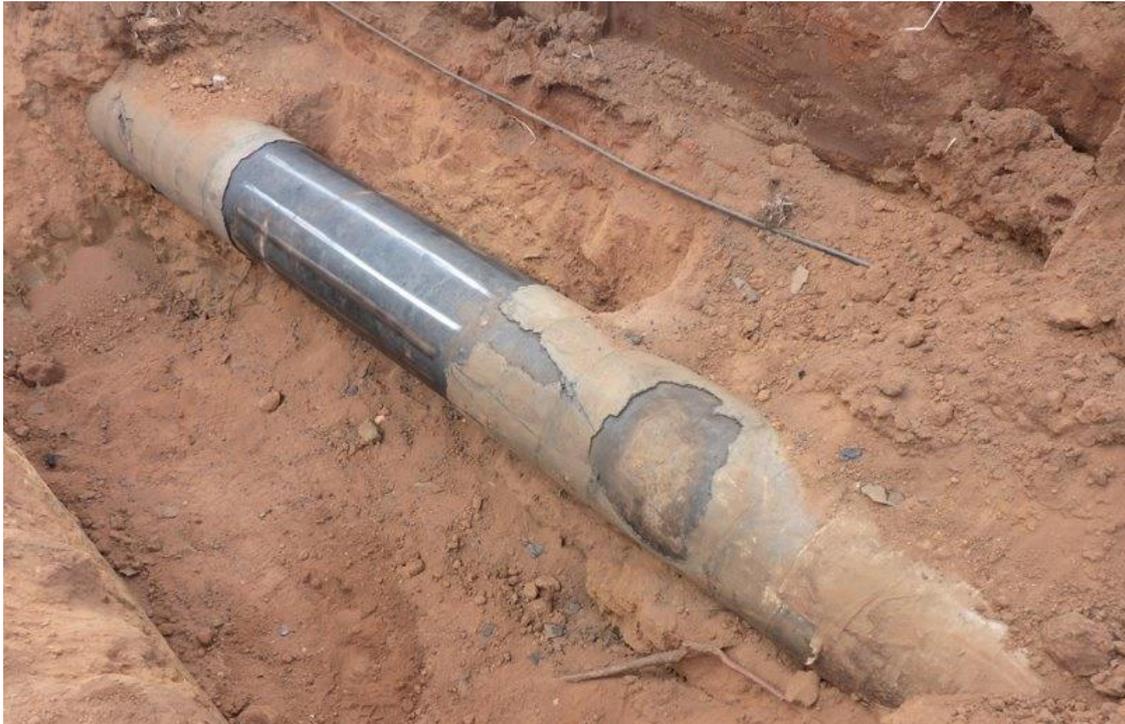
Figure 15 - DN300 Damaged asbestos coal tar coated pipe at York.

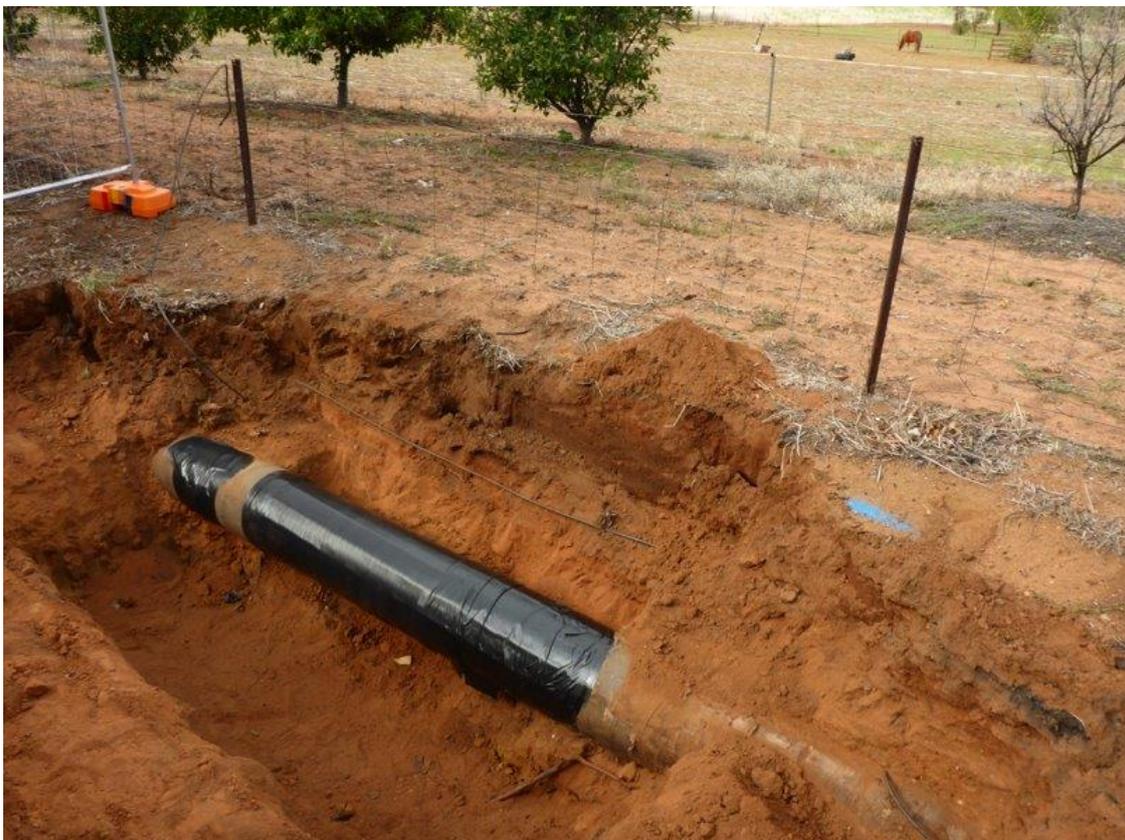
Figure 16 - DN300 Damaged asbestos coal tar coating repaired using non-hazardous repair system (primer, butyl mastic strip and PVC tape) .

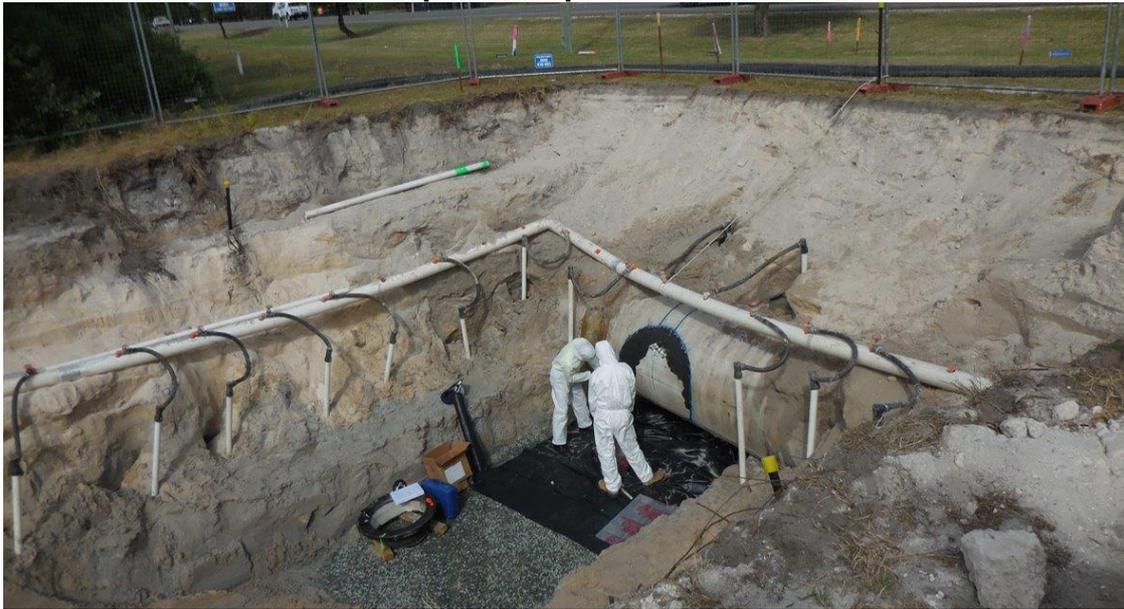
Figure 17 – Removal of asbestos coal tar coating from DN1400 main prior to welding in East Rockingham. Note the spiral wrapping of the bandage and intact whitewash coating.

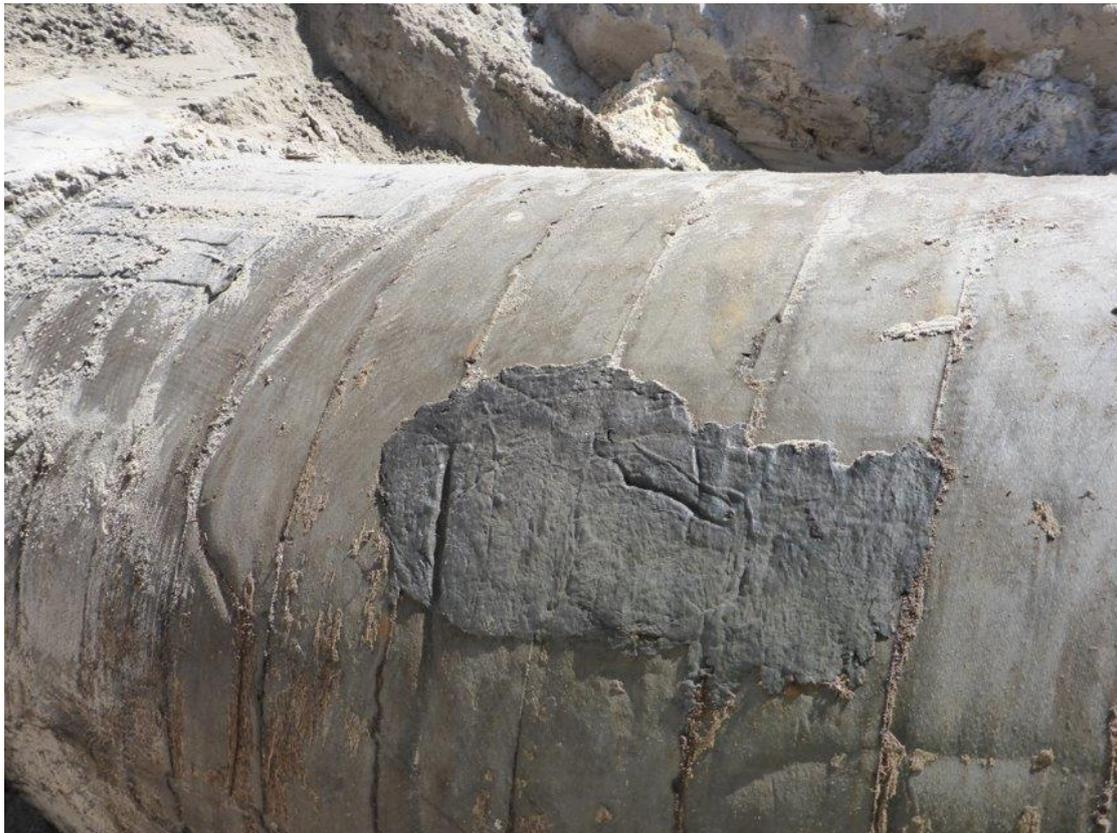
Figure 18 - DN1220 Serpentine trunk main, Riverton (installed 1953). Note the spiral bandage wrap and a mastic patch repair.

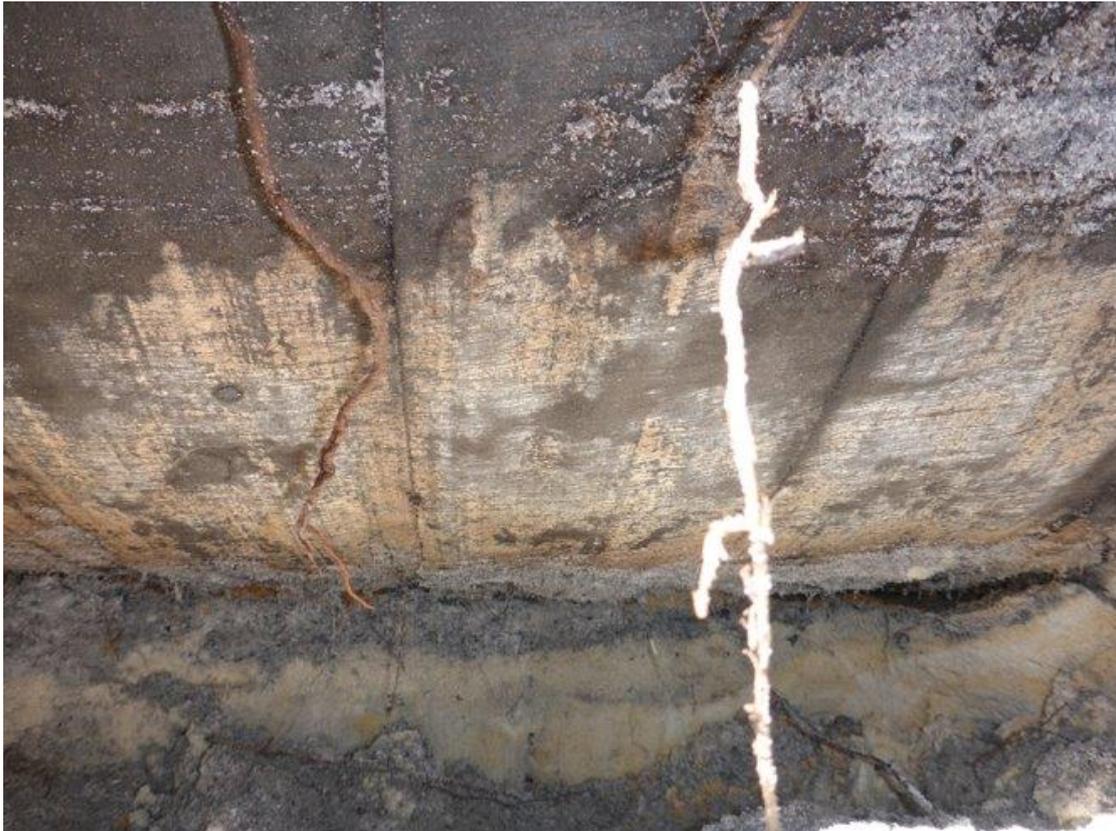
Figure 19 – Underside of the DN1220 Serpentine trunk main, Riverton (installed 1953). Note the remnant whitewash coating.

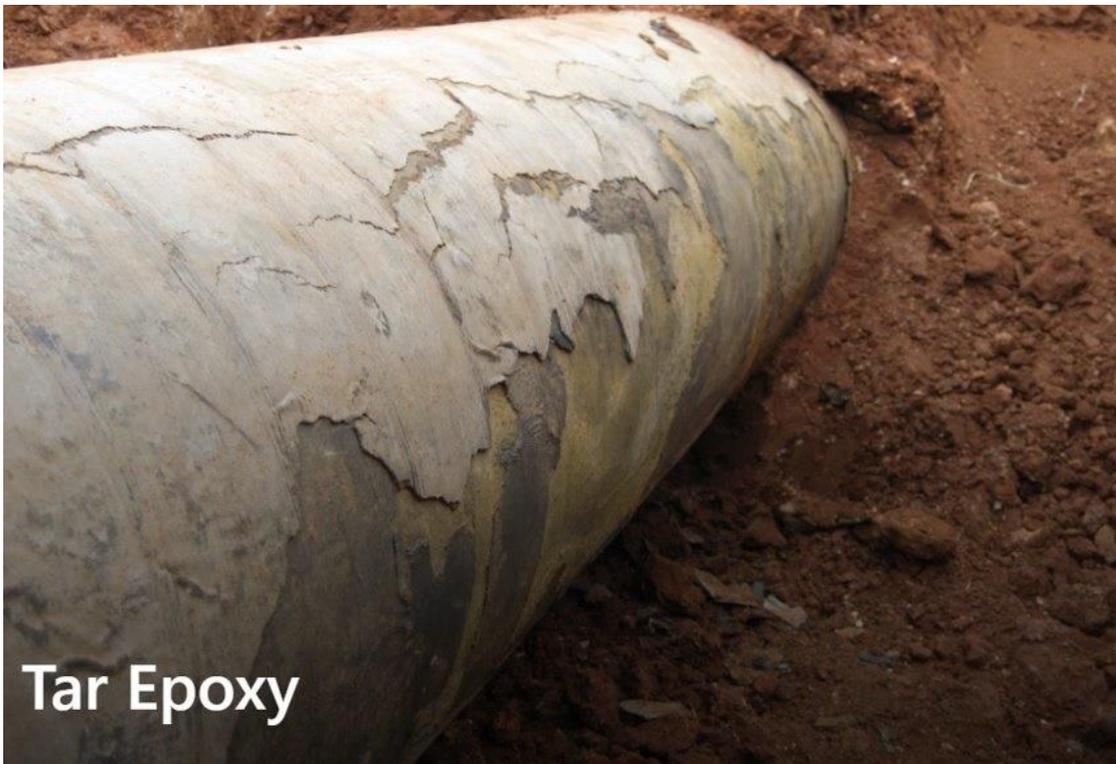
Figure 20 – Damaged asbestos coal tar coating at an unknown location. Note the remnant whitewash, spiral bandage wrap, black substrate.

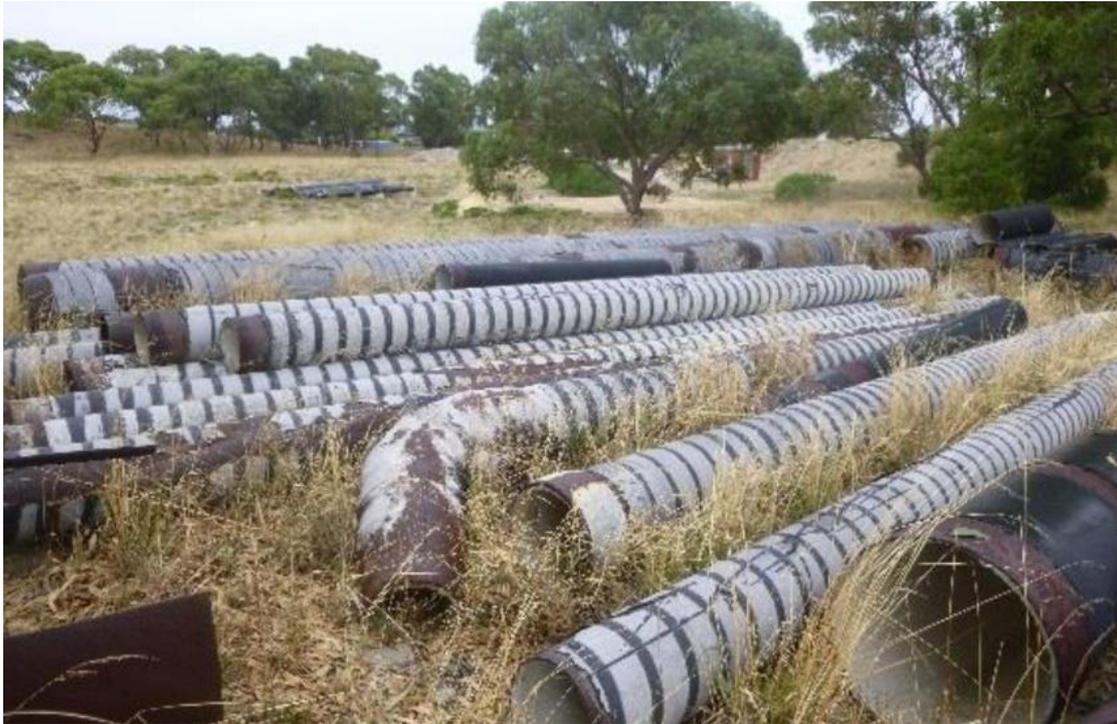
Figure 21 - Weathered asbestos coal tar coated pipe at Bold Park reservoir site. Note the spiral wrap and fading of the coating to a light grey.

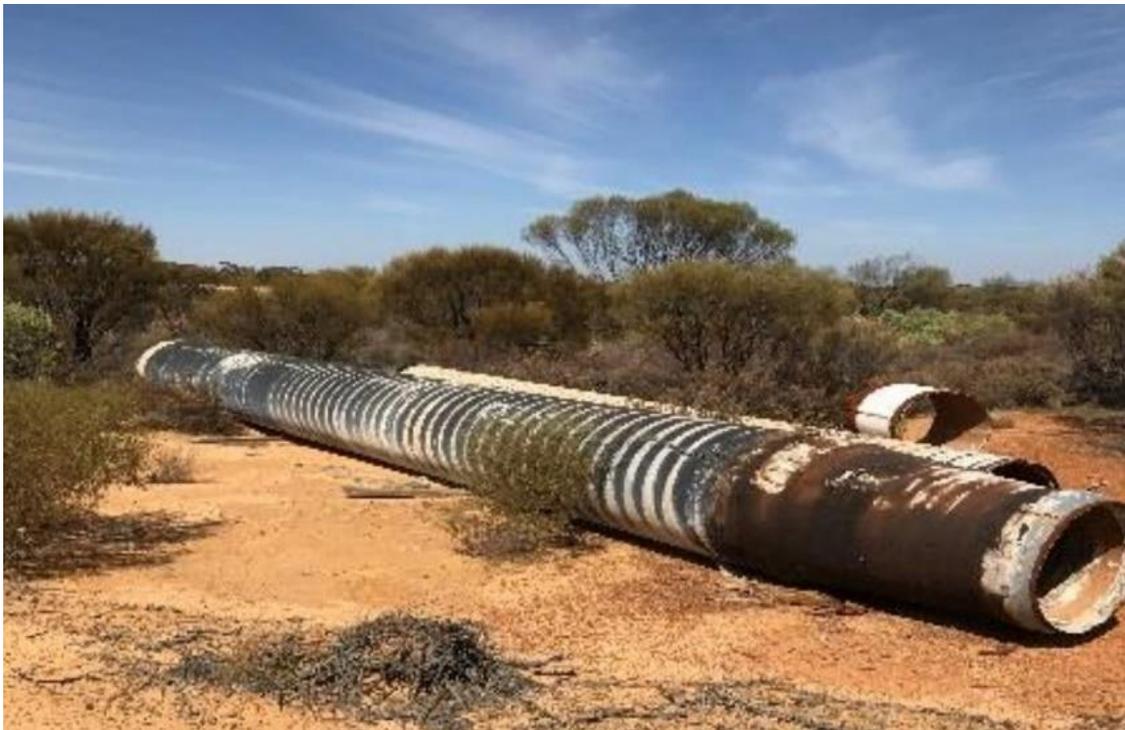
Figure 22 - Weathered asbestos coal tar coated pipe at Boondi Pump Station. Note the spiral wrap and the remnant whitewash, especially on the underside of the pipe.

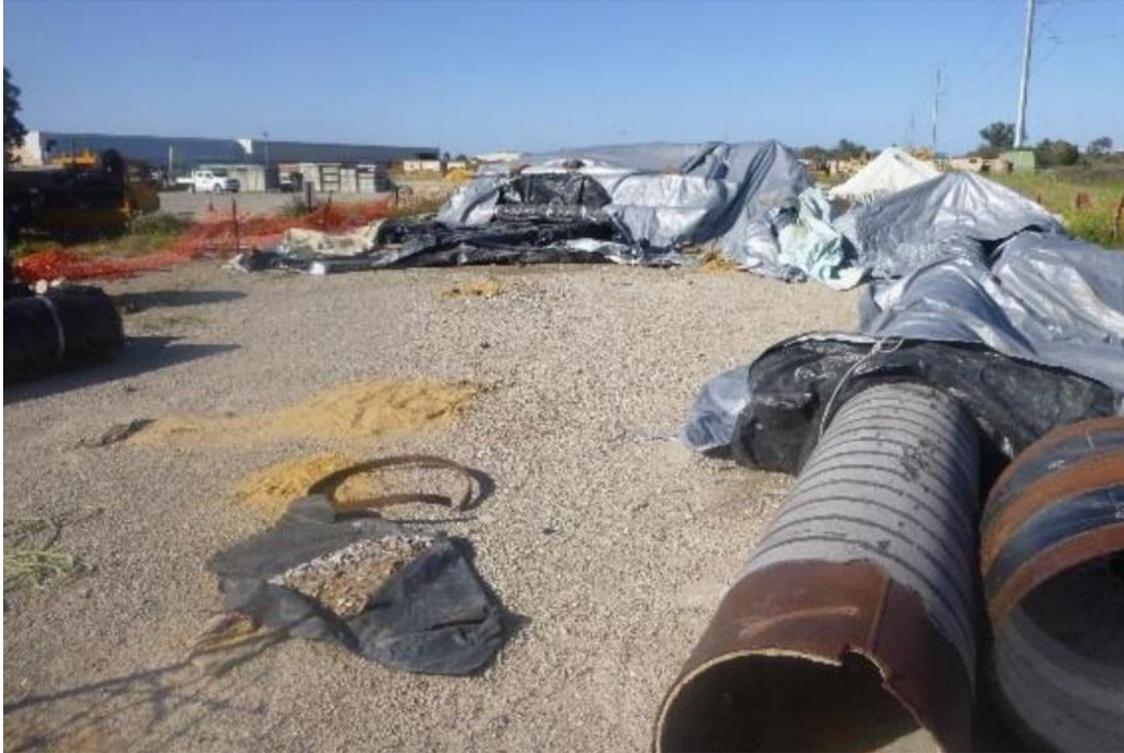
Figure 23 - Weathered asbestos coal tar coated pipe at Canning Vale Depot. Note the spiral wrap and coating colour weathered to light grey.

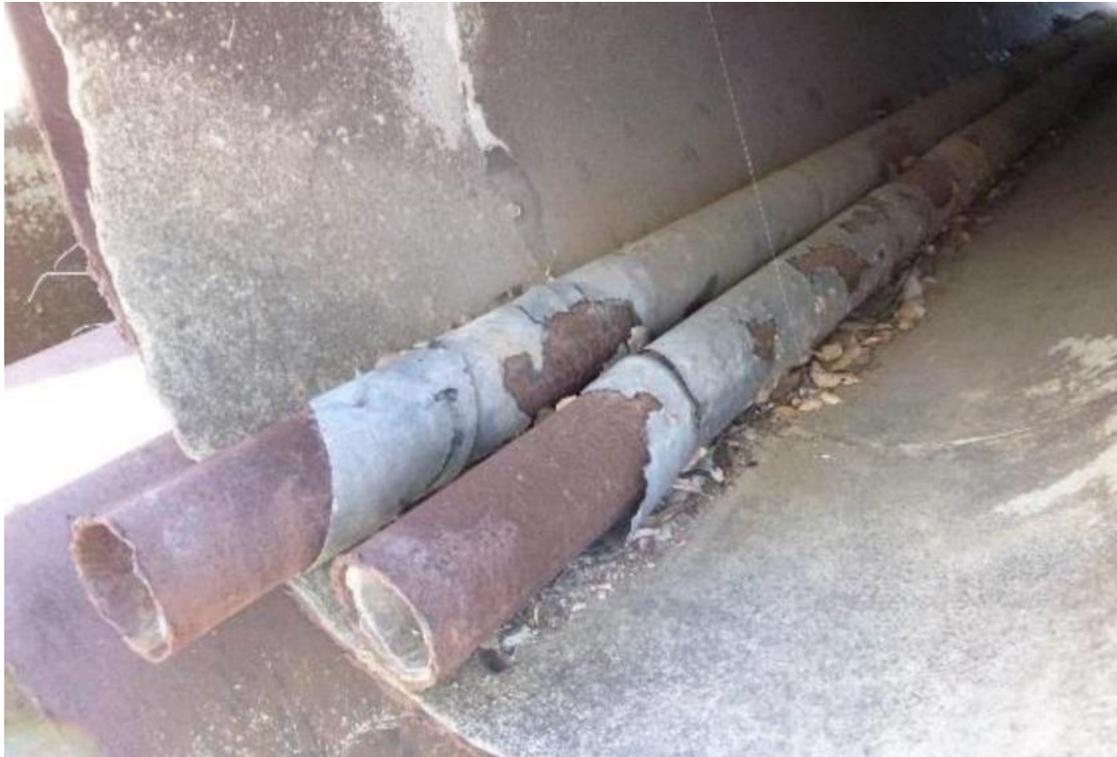
Figure 24 - Weathered small diameter asbestos coal tar coated pipe at Chidlow Pumping Station. Note the spiral wrap and coating colour weathered to light grey.

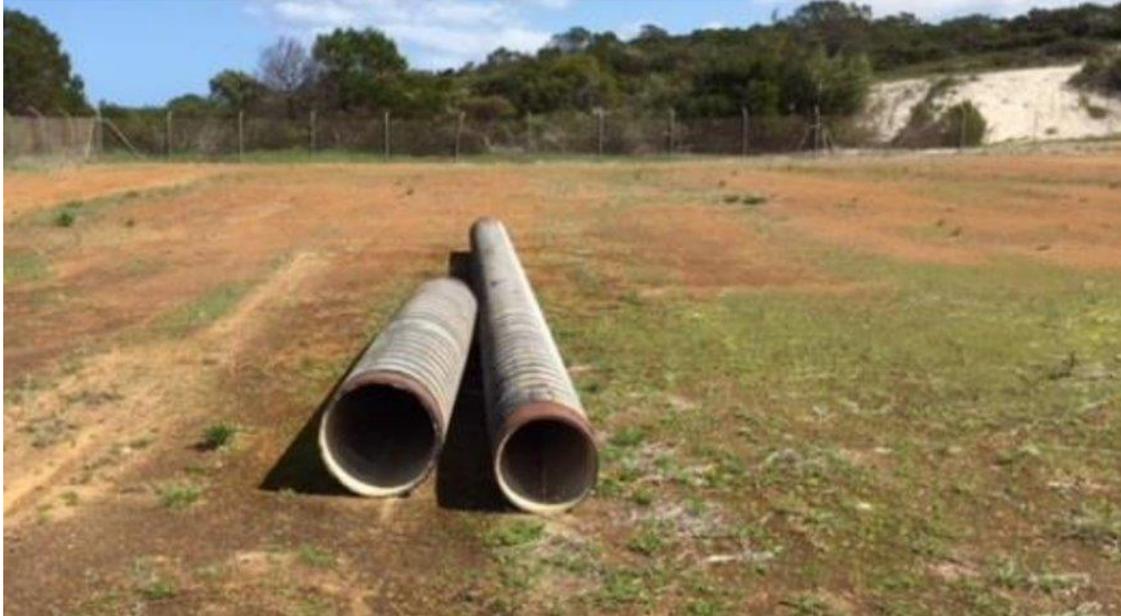
Figure 25 - Weathered asbestos coal tar coated pipe at Thompson Street WPS, Esperance. Note the spiral wrap, remnant whitewash and coating colour weathered to light grey.

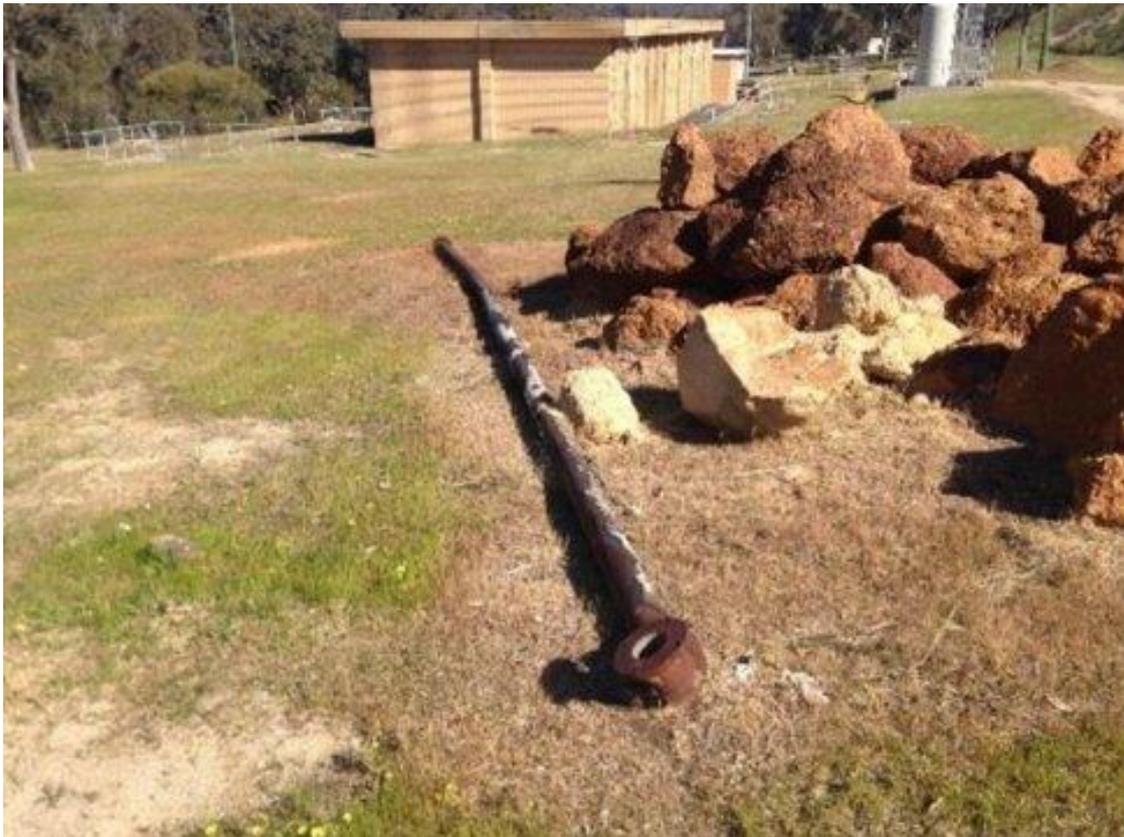
Figure 26 - An example of a less common CTE coating - Inner asbestos felt and outer protective layer (possibly fibreglass) at Greenmount Reservoir.

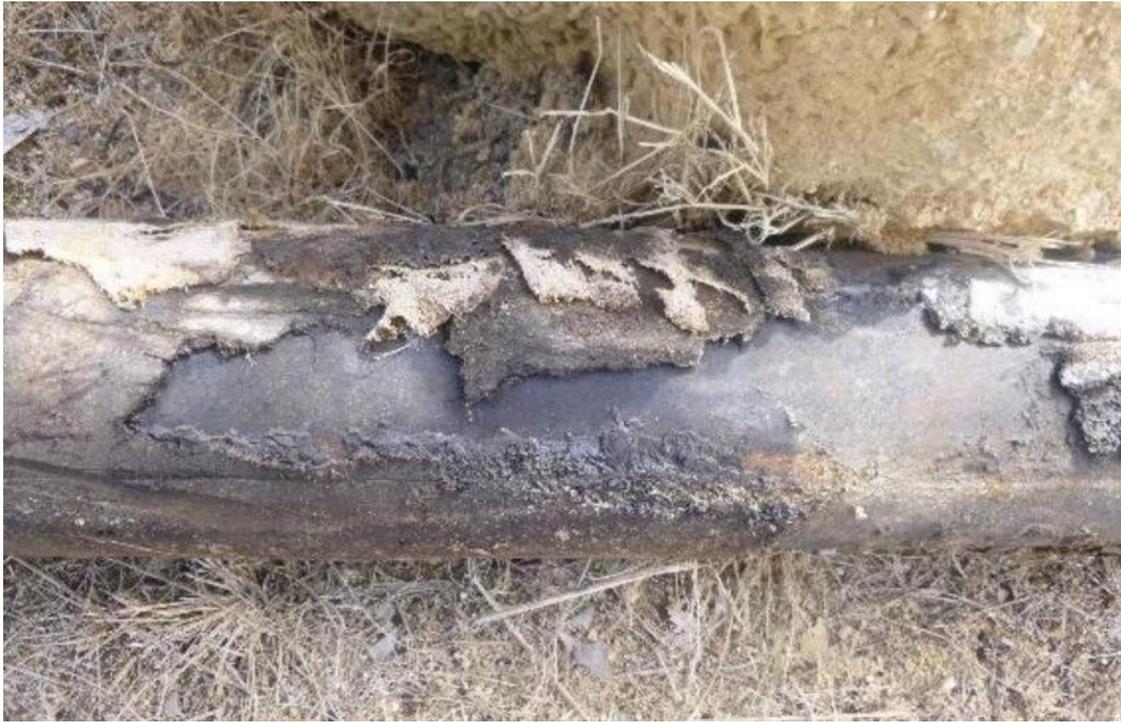
Figure 27 - Close-up of Greenmount pipe with a less common type of CTE coating consisting of an inner asbestos felt and outer protective layer (possibly fibreglass).
