| Doc ID #163240598 | Custodian Manager – Inspection and Condition Assessment |

1 Purpose

The purpose of this document is to enable a non-expert to gain sufficient knowledge to be able to confidently identify the hazardous factory-applied pipe coatings that are commonly encountered by personnel working with Water Corporation assets. Images of a range of pipe examples are presented to illustrate the various ways a pipe coating can appear after many years of service, storage, or neglect.

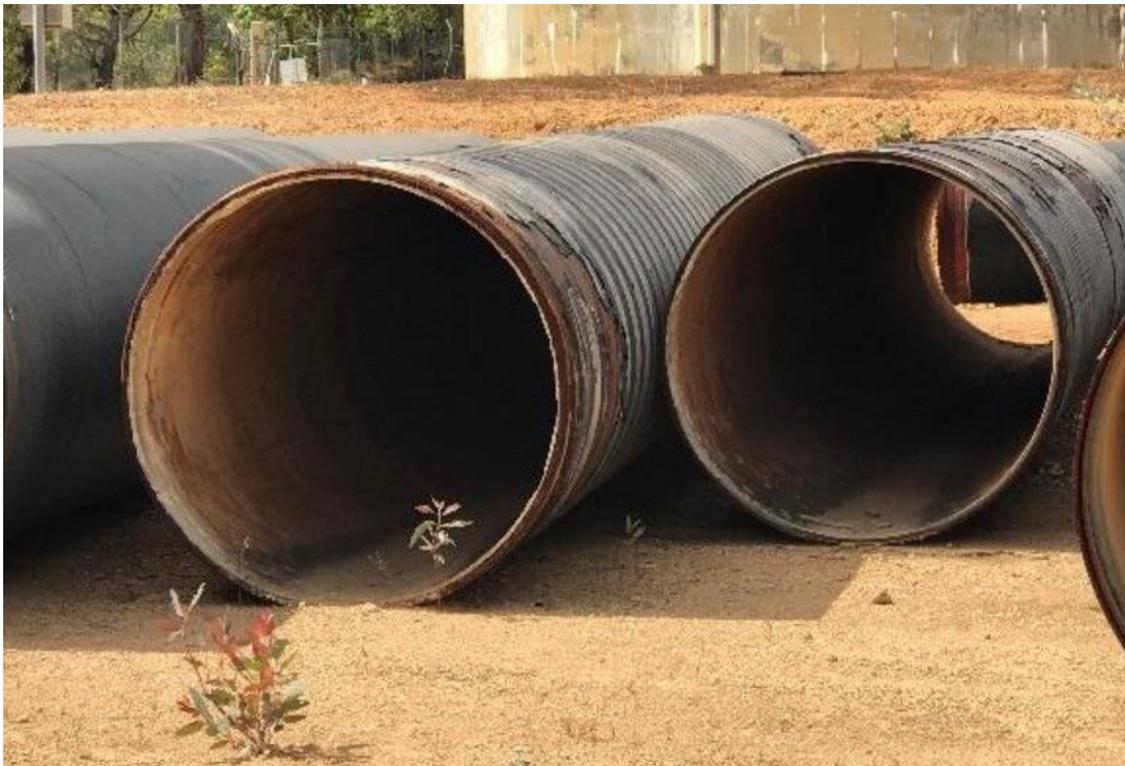
Figure 28 - Weathered asbestos coal tar coated pipe at Fleay Road, Harvey. Note the spiral wrap, remnant whitewash and coating colour weathered to light grey.

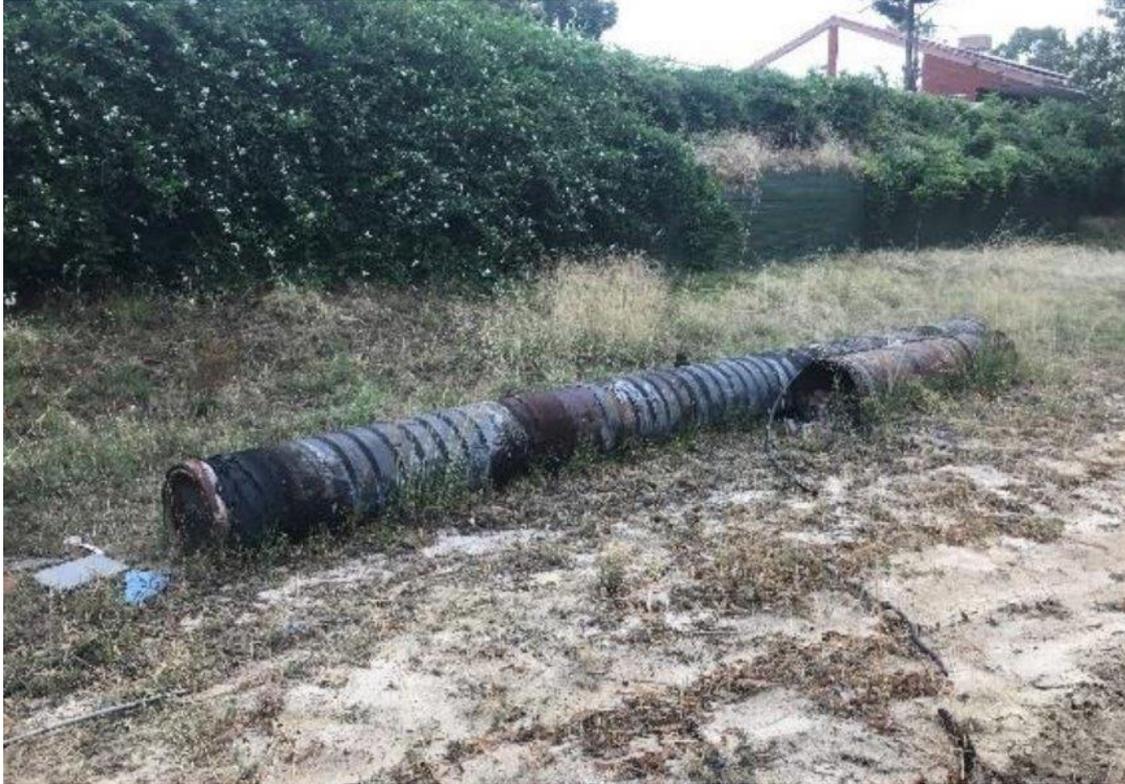
Figure 29 - Exhumed pipe at Lilac Place WWPS, Huntingdale. Note spiral wrap, coating colour weathered to grey and remnant whitewash.

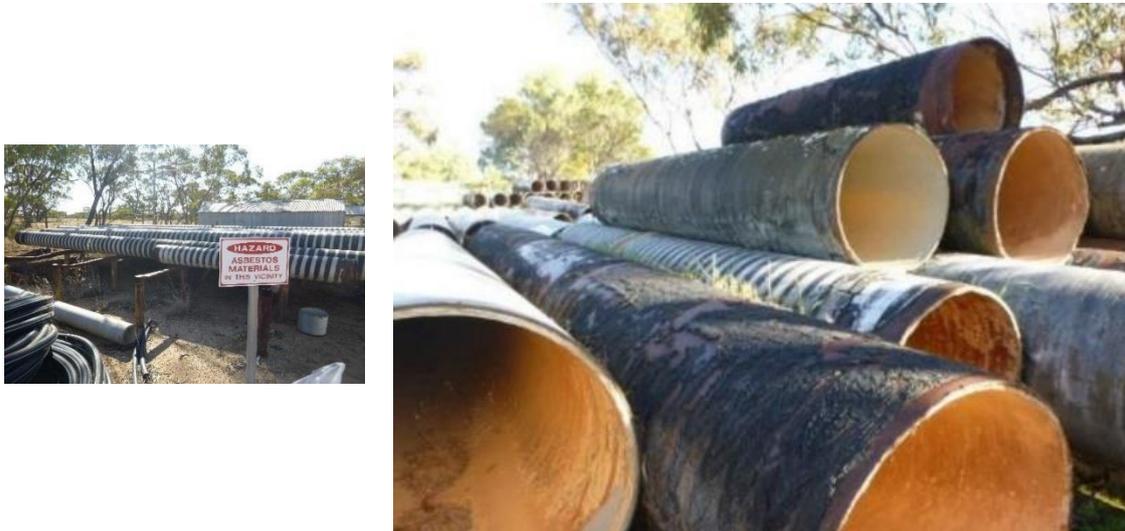
Figure 30 - Weathered coal tar coating at Kellerberrin Depot.

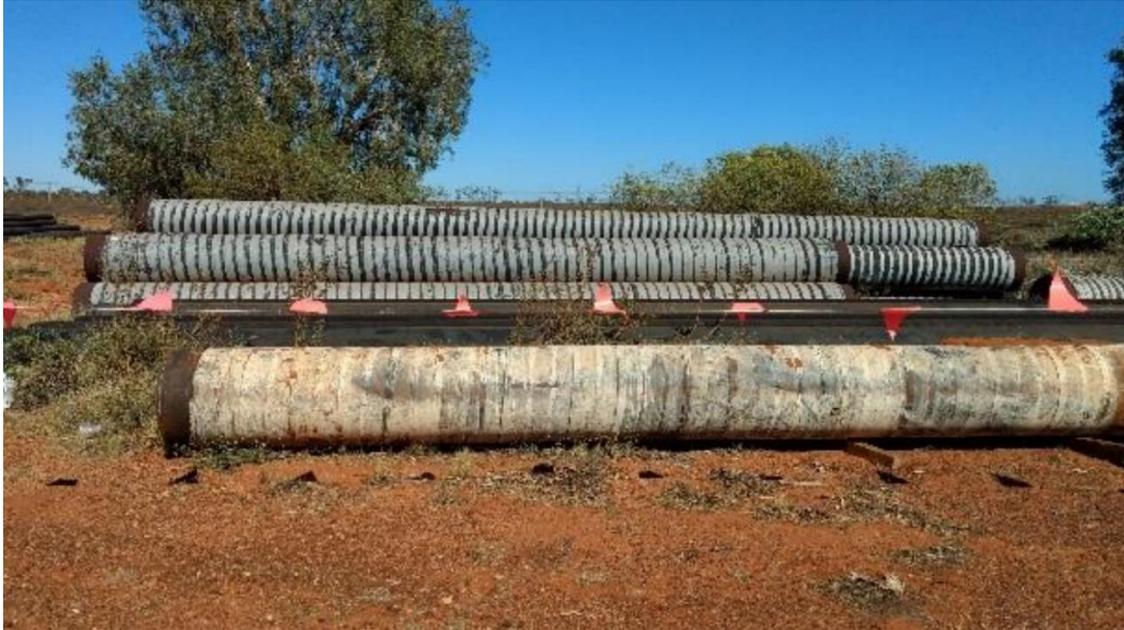
Figure 31 - Weathered asbestos coal tar coated pipes at South Hedland. Note the spiral bandage weathered to a light grey colour on the background pipes. The foreground CTE coated pipe has retained the protective whitewash over-coating.

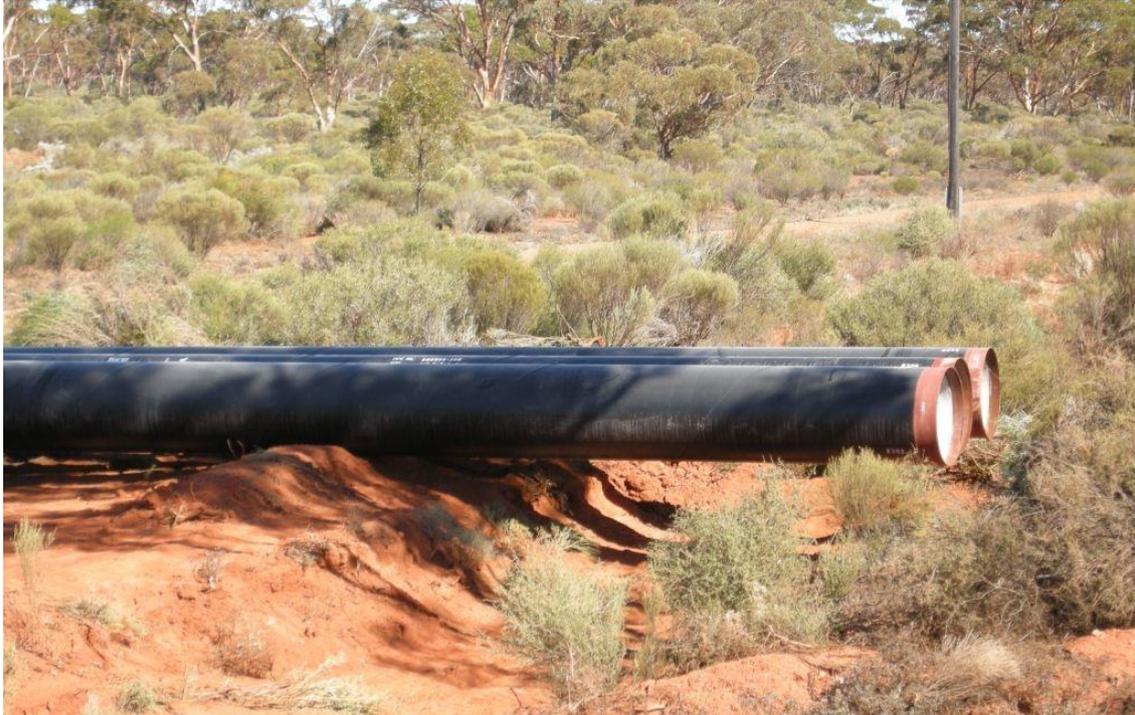
Figure 32 - New Sintakote pipe prior to installation. Note the smooth seamless black coating.

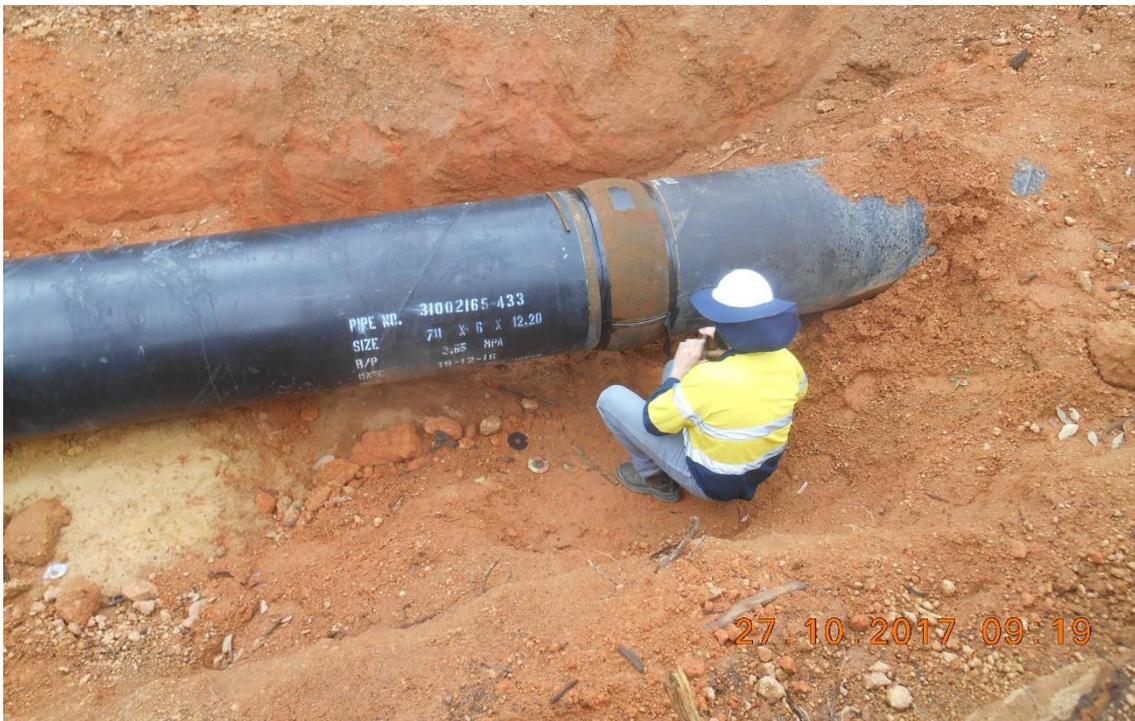
Figure 33 - New Sintakote pipe during installation. Note the smooth seamless black surface and the evident spiral pipe weld seam under the coating.

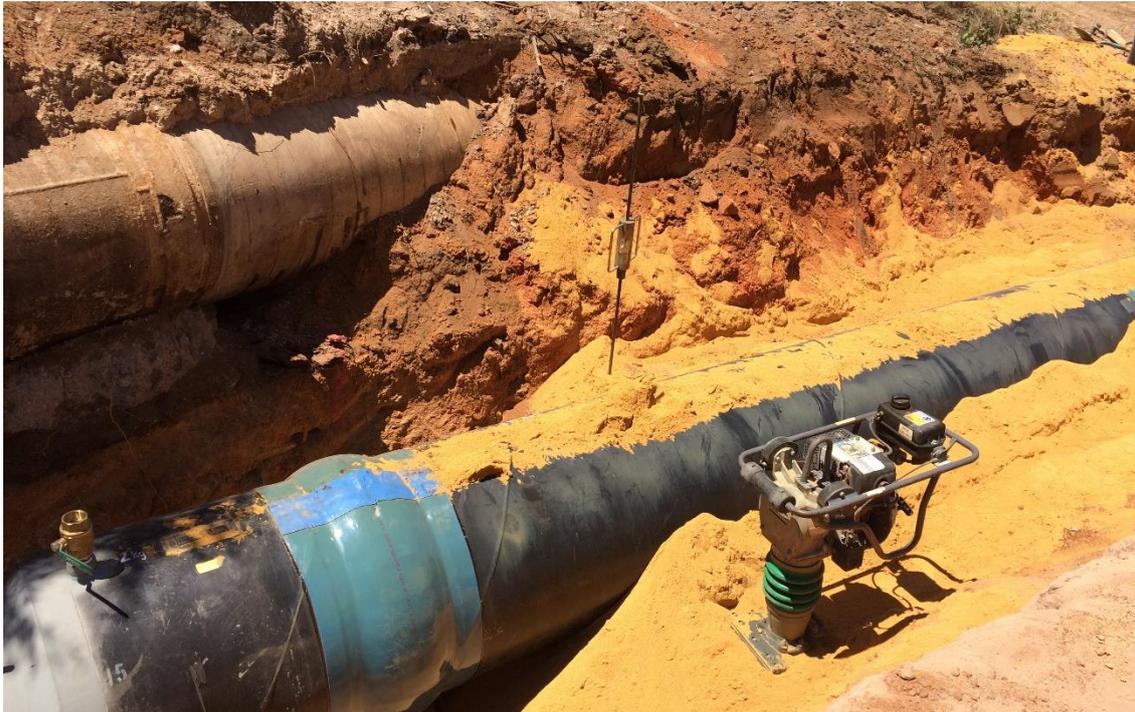
Figure 34 - New Sintakote pipe (foreground) during installation. Note the smooth seamless black surface and the spiral pipe weld seam evident through the coating. Older Asbestos CTE coated pipe in the background.
