Steel Tanks Condition Assessment Guideline

(Business Rules)

Water Corporation

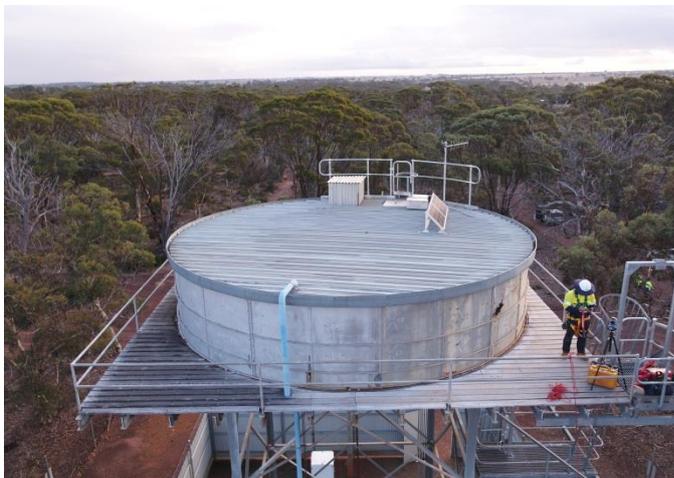
Photo 3 – Elevated Steel Tank.

The nominal capacity of existing elevated tanks ranges from 100kL to 4000kL. The elevated tanks are also internally coated with two packs of epoxy coating or lined with plastic liner. The tanks may be internally protected with sacrificial anode cathodic protection system.

There are two types of steel tanks in the Water Corporation, namely Ground Level Tank and Elevated Tank. The ground level tank which is generally cylindrical water storage structure constructed with the floor at ground level [**Refer: Photo 1 & 2**]. Exceptions are a few of the ground level liners tanks do not have steel floor plates welded to the wall. Elevated tanks are water storage structures built with the floor above ground level, either supported on a stand or an integral support structure [**Refer: Photos 3 & 4**].

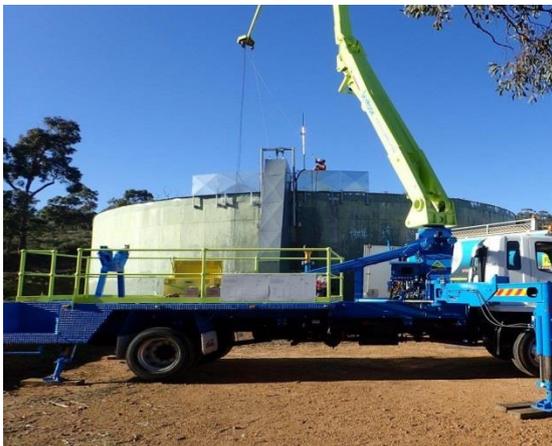
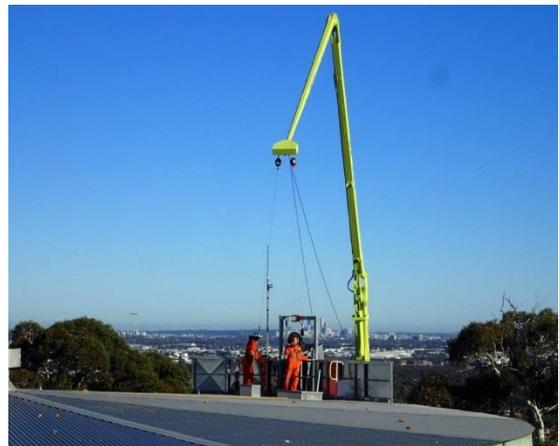
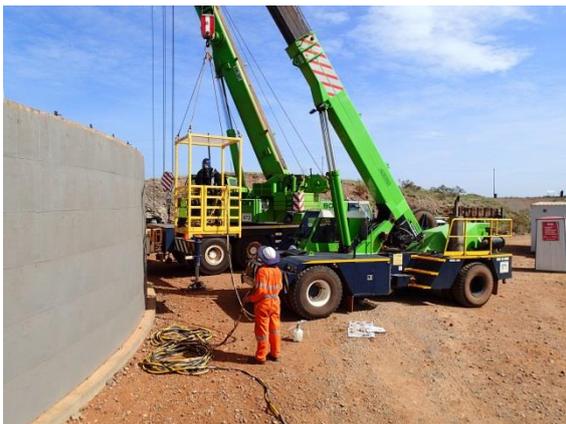
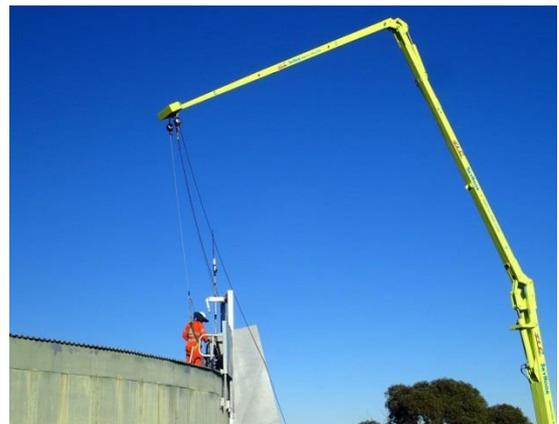
Photo 5 – Use of Sky Hook for safe working on the tank roof.

During the diving operation(s), the Divers shall ensure they are hooked on to the “Skyhook” or similar safety equipment approved by Worksafe, WA [**Refer: Photo 5**].

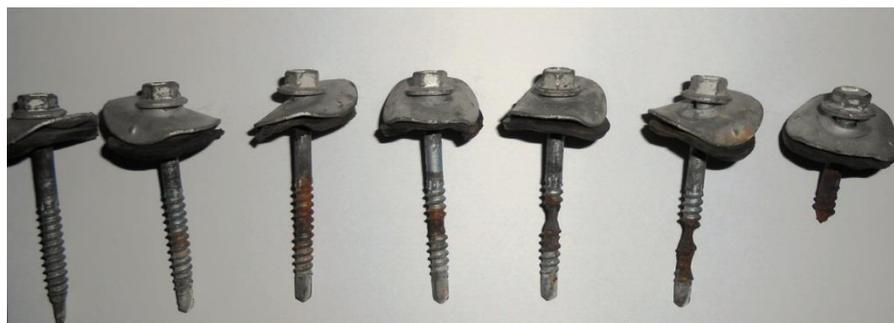
Photo 6 – Increasing “Localised Corrosion/Necking in Tek screw (Left to right).

If the tank components are noted with a regular pattern in corrosion, then they should be recorded and photographed in a sequence or the photos should be stitched [**Refer: Photo 6**].

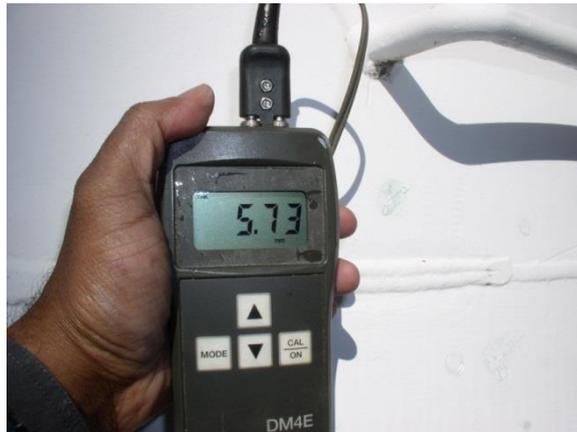
Photo 7 - Remaining Wall Thickness Measurement Gauge using UT gauge.

Ultrasonic Thickness (UT) Gauge is used to carry out remaining wall thickness measurement. The ultrasonic pulse emitted by the test probe reaches the test object and transits back to the probe. The time required for the ultrasonic pulse to travel through the material, reflect from the back or inside surface of test material will be calculated as thickness of the material [**Refer: Photo 7**].

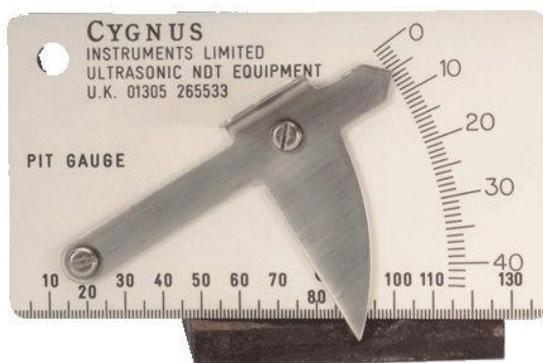
Photo 8 - Underwater Cygnus® Pit Gauge.

Pitting corrosion is quantified in different ways e.g. average pit depth measurement, maximum pit depth measurement and remaining wall thickness [**Refer: Photos 8 & 9**].

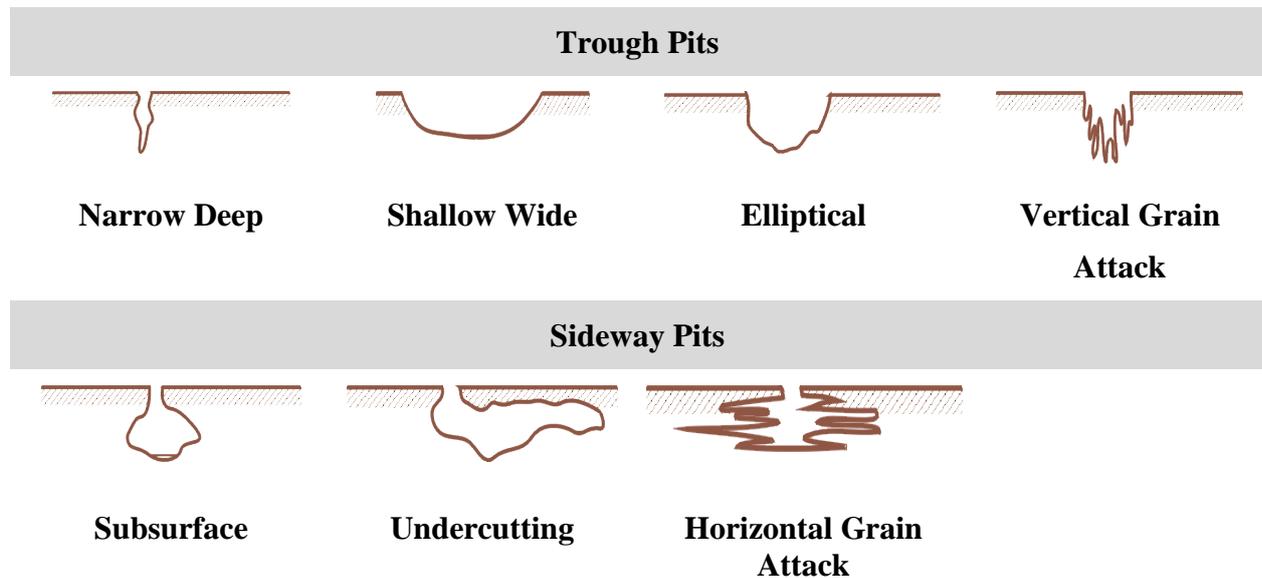
Figure 3 - Types of Pitting Corrosion [Ref: <http://www.nace.org/Pitting-Corrosion/>].

Pitting corrosion is a localized type of corrosion in the form of holes that can penetrate in materials extremely rapidly [**Refer: Figures 2 & 3**]. It is one of the most frequent forms of corrosion in steel water tanks, mainly caused by chlorides [8].

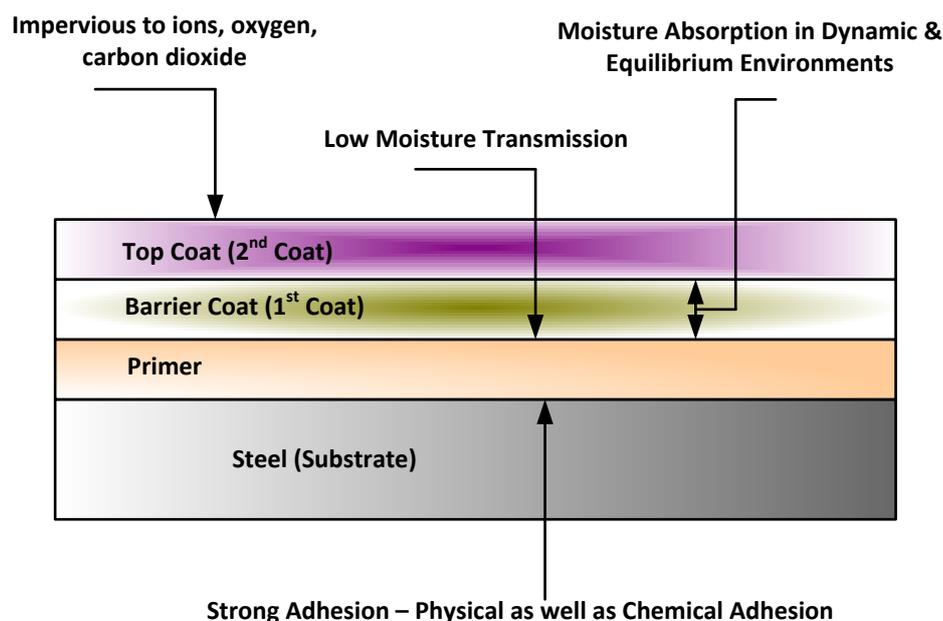
Figure 4 – Schematic drawing of a typical three coat system.

Steel usually rusts when it is exposed to water and oxygen through the formation of tiny electrical cells on the surface. Protective coatings provide a barrier to oxygen, moisture and other corrosive elements. For optimum protection, the barrier should be as impermeable, adequately thick, and continuous as practical. The surface to be coated is called the substrate. The coatings applied on the substrate can be made of a single coat or multiple coats [Refer: Figure 4].

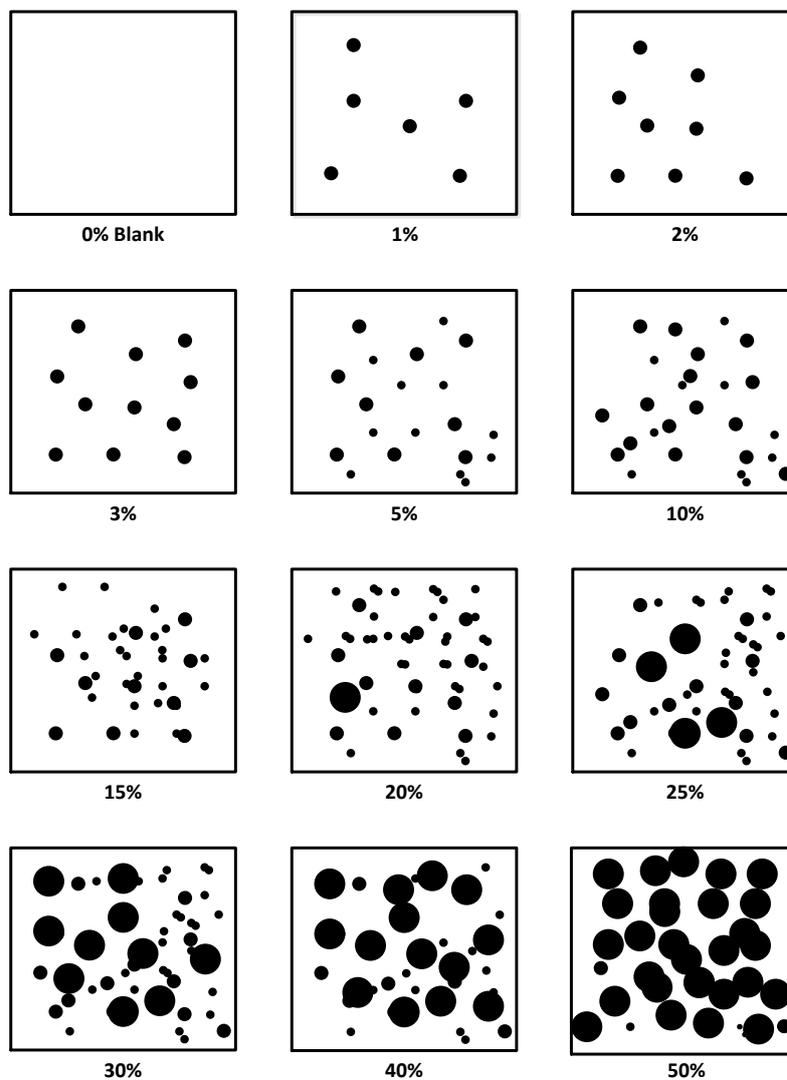
Figure 5 – Schematic representation of estimating rust percentages in 1 m2 area.

Degree of Rusting is defined as the rating characterising the degree of rust formation (rust broken through and visible under rust) on a coating. This assessment should be carried out under good lighting. The degree of rust percentage is explained in the following schematic representations. These are also known as “Measles Charts” as shown in Figure 5. References shall also be carried out to SSPC Standard, SSPC Vis 2 for details [9]. Repair painting is also necessary in the following typical cases:

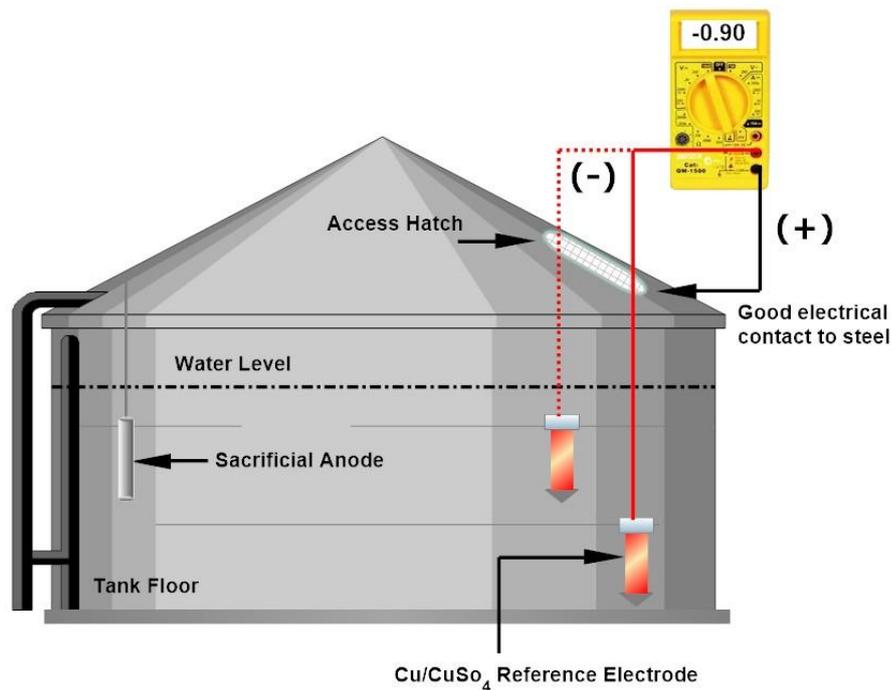
Figure 6 – CP potential measurement in the steel tank using portable Cu/CuSO₄ reference cell.

Divers should check if the steel tank is cathodically polarised (protected) by dropping reference electrode (e.g. Copper/Copper Sulphate) through the access hatch and measure the potential around the roof hatch before CP is turned off [**Refer: Figure 6**].

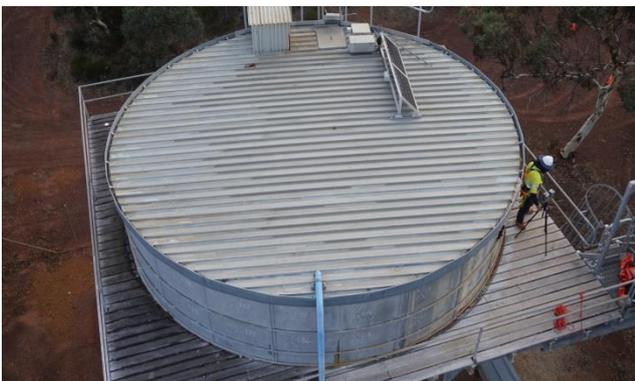
Photo 10 – Inspection of the elevated tank roof using RPA.

Level 1 inspection is carried out as part of routine operational budgets and activities. Refer **Appendix A** inspection checklist for Level 1 inspection by Water Corporation employees and external Inspection Service Providers (ISP's). In the Corporation, the following inspection activities are classified as Level 1 inspection [**Refer Photos 10 & 11**].

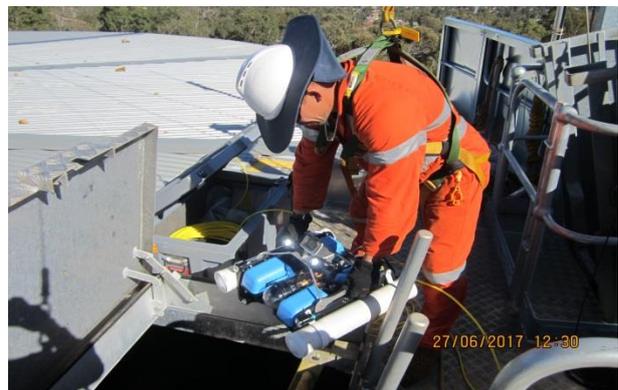
Photo 11 – Tank internal inspection using ROV.

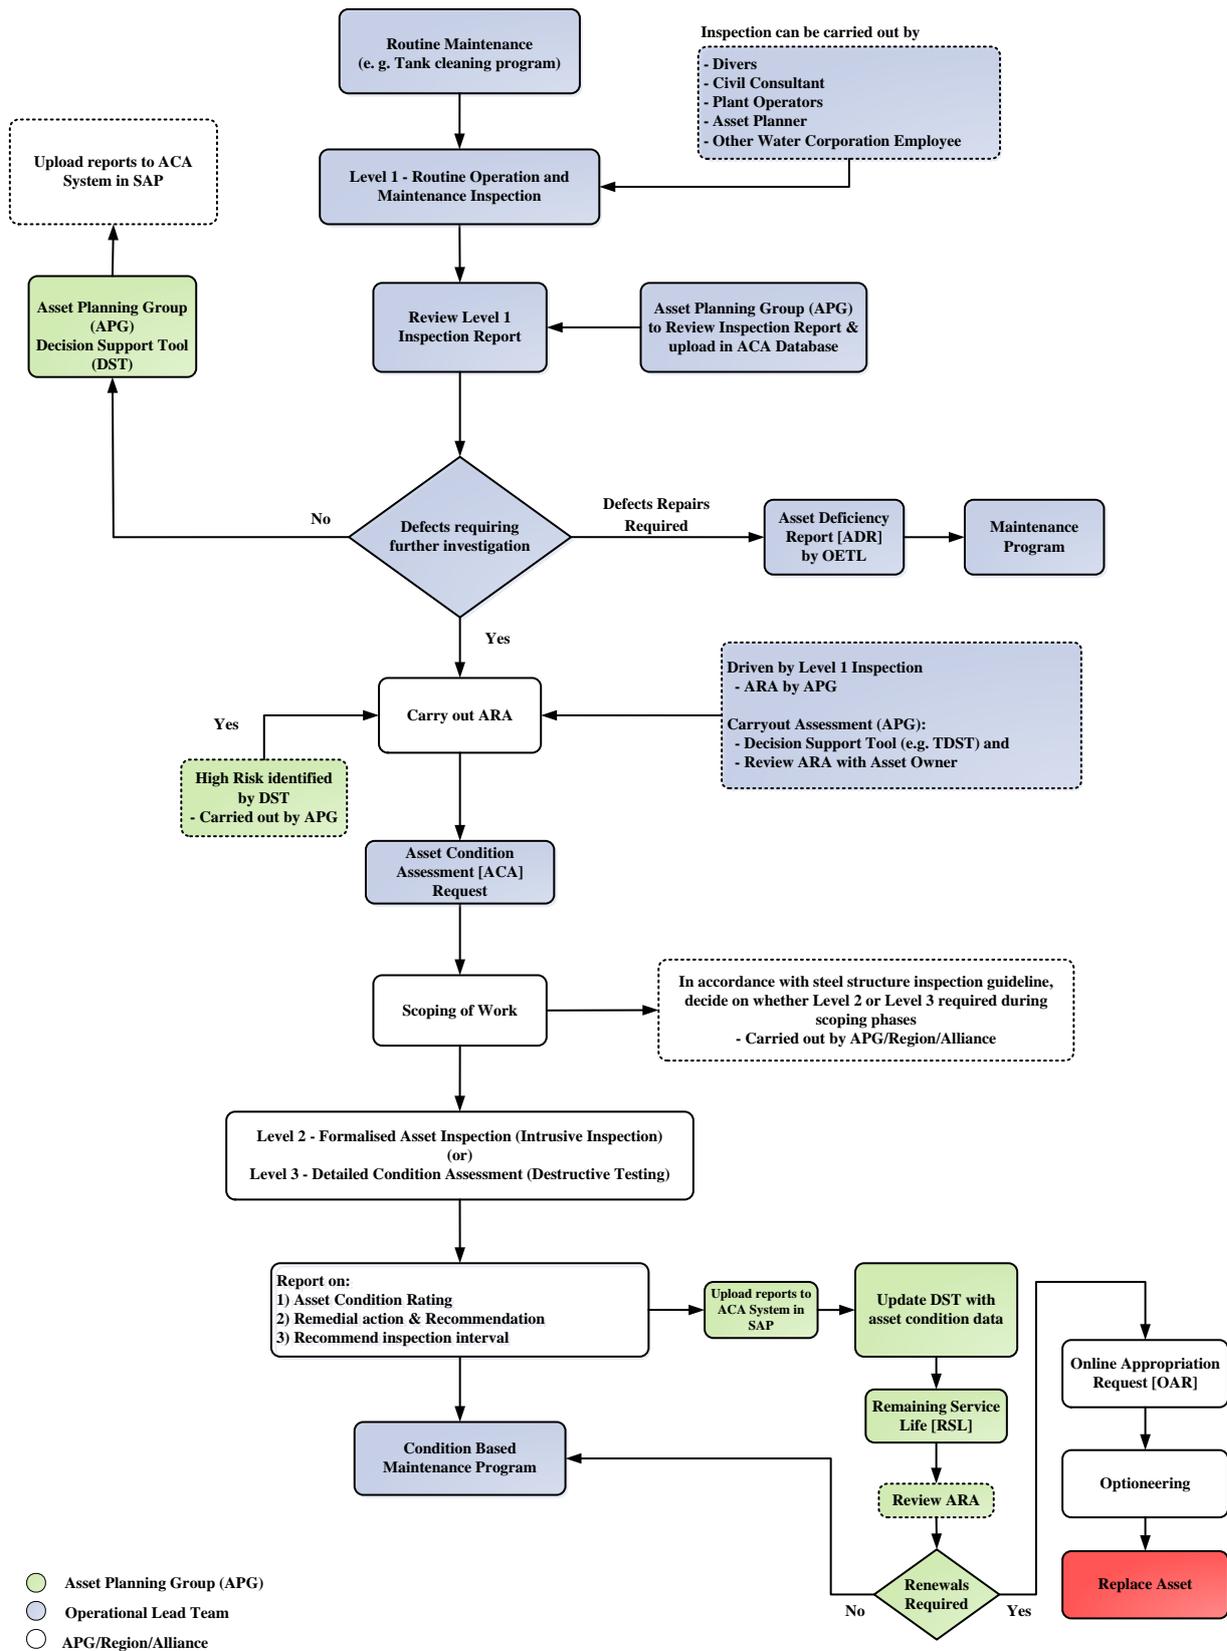
Figure 7 - Summary of the steel structure inspection guidelines.

An overview of the process is depicted in **Figure 7** with each stage explored in further detail in the following sections. Level 3 inspection is carried out as part of the planned condition assessment capital program.

The inspection finding shall be reported to OAM/Regional Alliance/APG. If the defects deemed to be significant, then OAM will conduct an ARA. APG will review the ARA and is discussed in Section 3.0 [**Refer: Figure 7 - Summary of the steel structure inspection guidelines**].

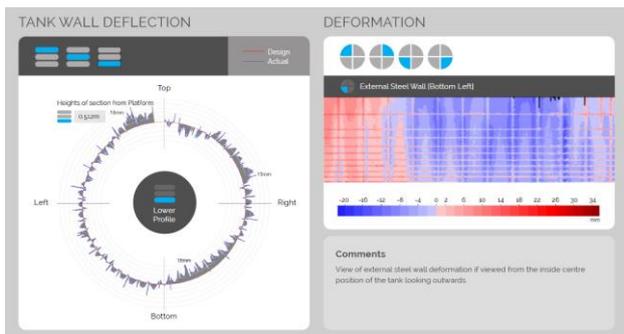
Figure 8 – Out of shape/roundness of the steel tank wall

Figures 8 and 9 show some of the tank integrity assessments inferred from Level 2 inspection activities.

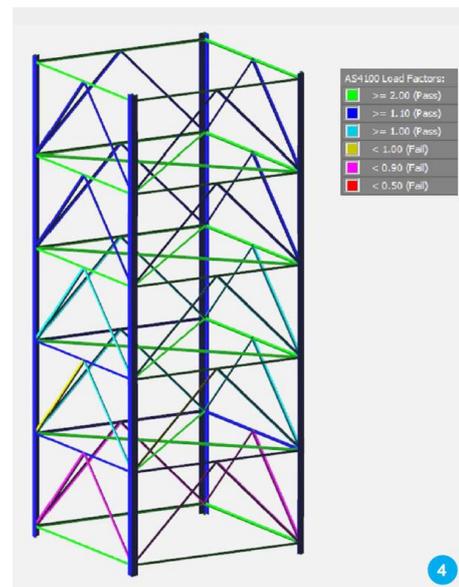
Figure 9 – Steel tank stand structural analysis using proprietary software.

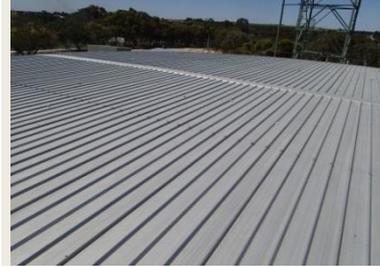
5 or 6	Good	<ul style="list-style-type: none"> Moderate corrosion/deterioration observed on the roof sheet Moderate surface rust to Tek Screws At times, random holes are observed on the roof sheet

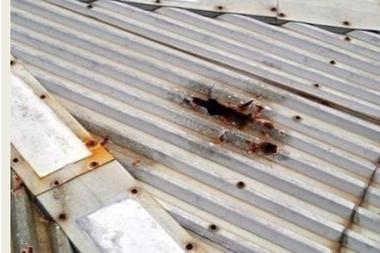
7 or 8	Fair	<ul style="list-style-type: none"> Severe corrosion/necking to the internal roof sheet support structures Sagging of roof sheet observed

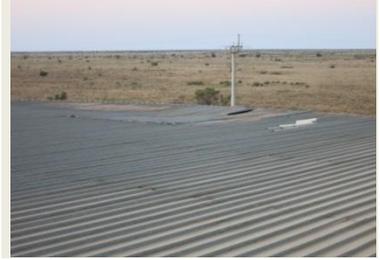
9	Poor	<ul style="list-style-type: none"> Imminent failure to roof sheet collapsing inside the tank High velocity wind may lift the roof sheeting off from the structure

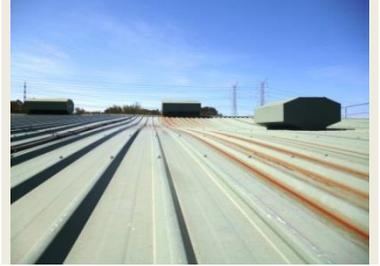
10	Very Poor	<ul style="list-style-type: none"> Tek Screw broken or disconnected from the roof sheeting

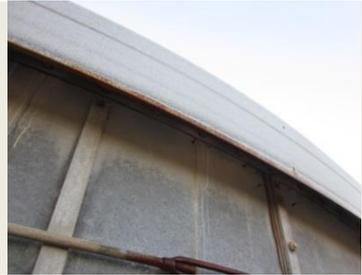
5 or 6	Good	<ul style="list-style-type: none"> Moderate corrosion/deterioration to wall coating Light surface rust to steel substrate Showing signs of hot dip galvanising (zinc) reaction with the environment

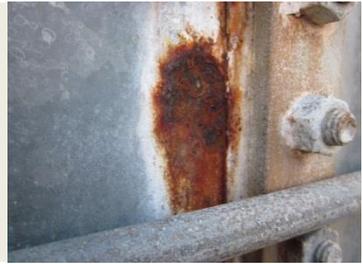
10	Very Poor	<ul style="list-style-type: none"> Severe corrosion/ on the wall Severe signs corrosion build up on most of the wall surfaces Imminent leak due to steel corrosion

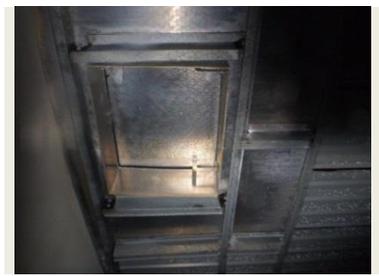
3 or 4	Very Good	<ul style="list-style-type: none"> Minor corrosion/deterioration to zinc coating Light surface rust to steel substrate

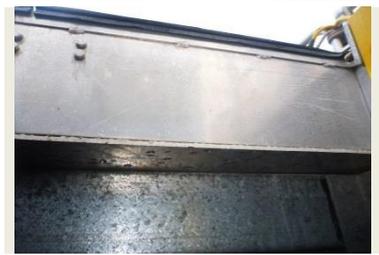
5 or 6	Good	<ul style="list-style-type: none"> Moderate corrosion/deterioration to access coating Light surface rust to steel substrate

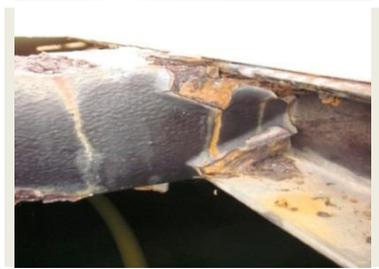
7 or 8	Fair	<ul style="list-style-type: none"> Severe corrosion due to hot dip galvanising coating deterioration Severe surface rust noted on large areas

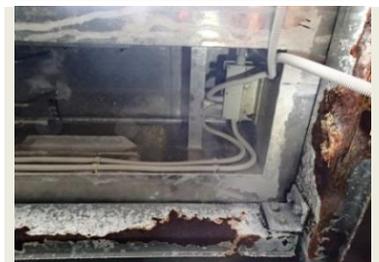
9	Poor	<ul style="list-style-type: none"> Zinc coating delamination and failure of protective coating resulting in corrosion

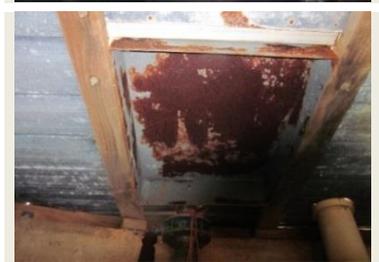
10	Very Poor	<ul style="list-style-type: none"> Severe corrosion/ on the access hatch Imminent failure due to steel corrosion

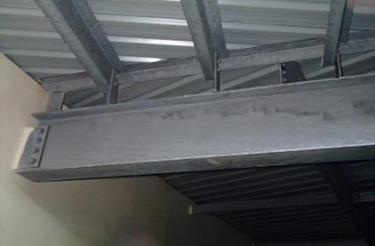
3 or 4	Very Good	<ul style="list-style-type: none"> Minor corrosion/deterioration to roof beams Light surface rust resulting from hot dip galvanised zinc depletion

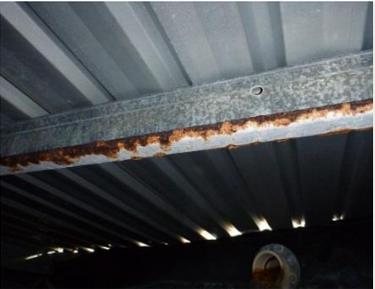
5 or 6	Good	<ul style="list-style-type: none"> Moderate corrosion/deterioration to roof beams Most of the hot dip galvanised zinc depleted on the roof beam

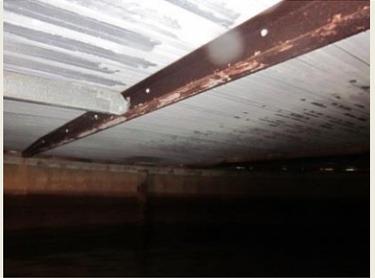
7 or 8	Fair	<ul style="list-style-type: none"> Severe corrosion to steel Early signs of lamellar corrosion

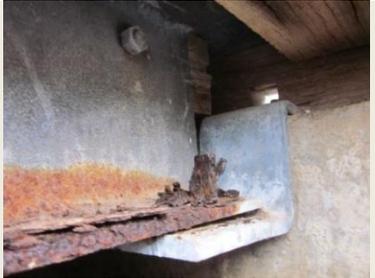
9	Poor	<ul style="list-style-type: none"> Severe corrosion to steel Severe signs of lamellar corrosion on larger areas of the component

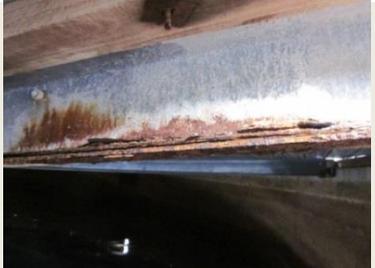
10	Very Poor	<ul style="list-style-type: none"> Imminent failure of the beams Failure on the weld joints

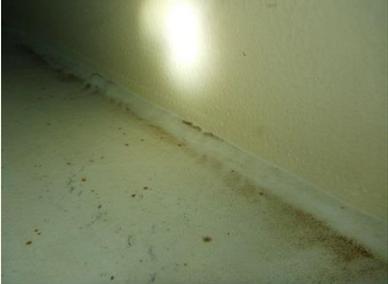
ACA Rating	ACA Outcome	Description	Descriptive Photograph
1 or 2	Excellent	<ul style="list-style-type: none"> No or very minor defects

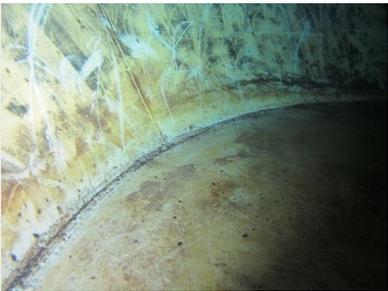
3 or 4	Very Good	<ul style="list-style-type: none"> Minor corrosion/deterioration to wall coating Light surface rust to steel substrate Random appearance of coating blisters

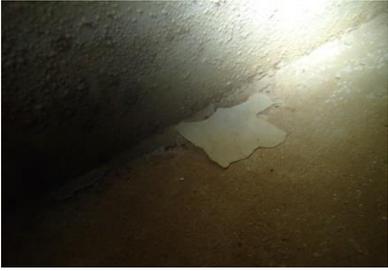
9	Poor	<ul style="list-style-type: none"> 100% coating "Osmotic blister" observed Coating delamination and failure of protective coating

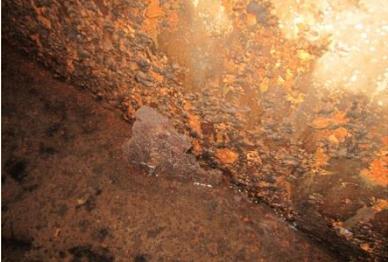
10	Very Poor	<ul style="list-style-type: none"> Severe corrosion/ on the wall Severe signs corrosion build up on most of the wall surfaces

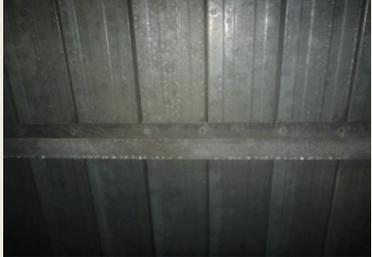
ACA Rating	ACA Outcome	Description	Descriptive Photograph
1 or 2	Excellent	<ul style="list-style-type: none"> No or very minor defects

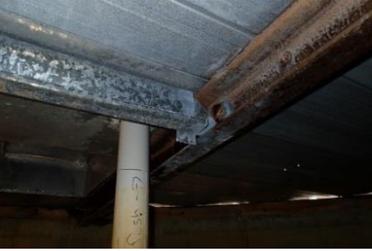
3 or 4	Very Good	<ul style="list-style-type: none"> Minor corrosion/deterioration to purlins Light surface rust resulting from hot dip galvanised zinc depletion

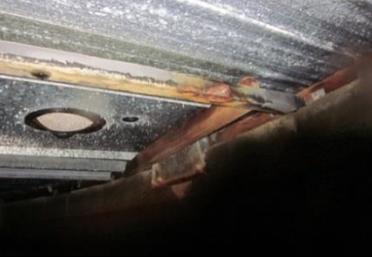
5 or 6	Good	<ul style="list-style-type: none"> Moderate corrosion/deterioration to purlins Most of the hot dip galvanised zinc depleted on the roof beam

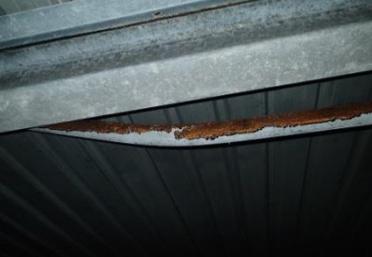
10	Very Poor	<ul style="list-style-type: none"> Imminent failure of the purlins

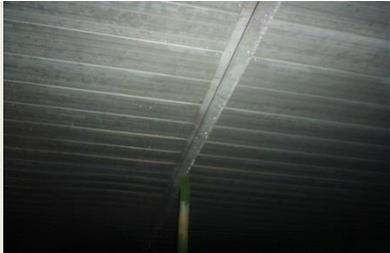
ACA Rating	ACA Outcome	Description	Descriptive Photograph
1 or 2	Excellent	<ul style="list-style-type: none"> No or very minor defects

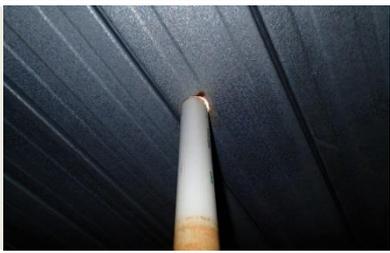
3 or 4	Very Good	<ul style="list-style-type: none"> Minor corrosion/deterioration observed on the roof sheet

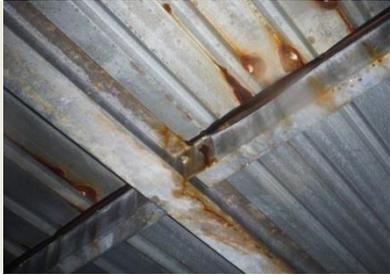
5 or 6	Good	<ul style="list-style-type: none"> Moderate corrosion/deterioration observed on the roof sheet Moderate surface rust to Tek Screws At times, random holes are observed on the roof sheet

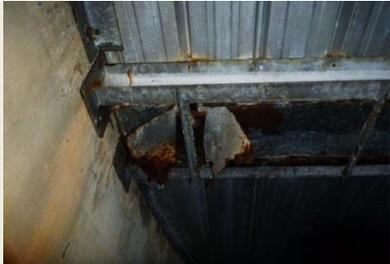
7 or 8	Fair	<ul style="list-style-type: none"> Severe corrosion/necking to the internal roof sheet support structures

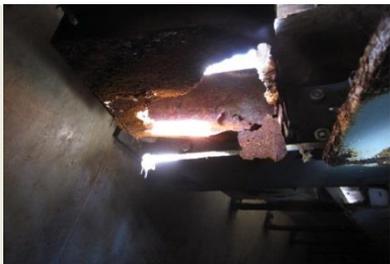
9	Poor	<ul style="list-style-type: none"> Imminent failure to roof sheet collapsing inside the tank High velocity wind may lift the roof sheeting off from the structure

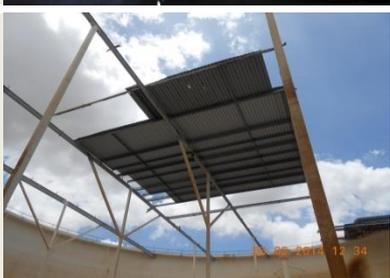
10	Very Poor	<ul style="list-style-type: none"> Tek Screw broken or disconnected from the roof sheeting <p>Roof</p>

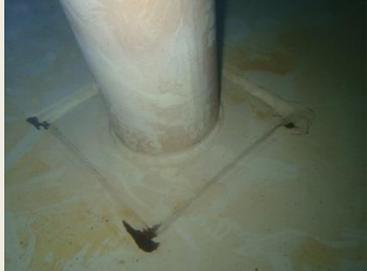
ACA Rating	ACA Outcome	Description	Descriptive Photograph
1 or 2	Excellent	<ul style="list-style-type: none"> No or very minor defects

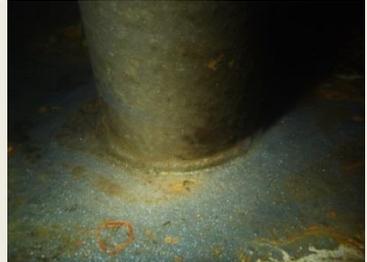
3 or 4	Very Good	<ul style="list-style-type: none"> Moderate deterioration to the column coating

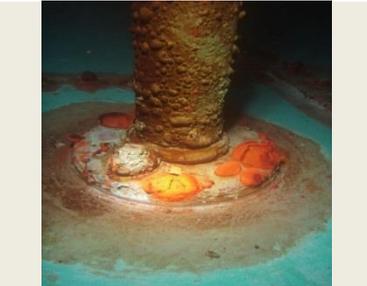
5 or 6	Good	<ul style="list-style-type: none"> Moderate deterioration with signs of coating blisters Corrosion on the hold down bolts are observed

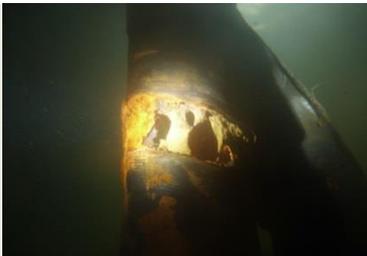
9	Poor	<ul style="list-style-type: none"> Severe corrosion on the columns At times, large pitting corrosion (holes) are observed

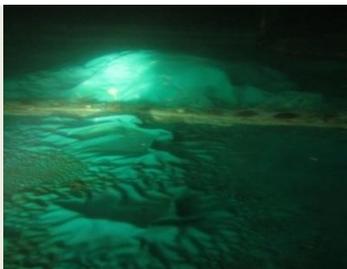
5 or 6	Good	<ul style="list-style-type: none"> Bubbles on the plastic lining Possible damage to the liner around those areas

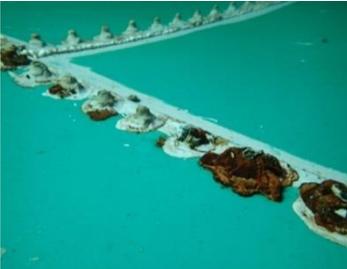
7 or 8	Fair	<ul style="list-style-type: none"> Signs of corrosion on the tank hold down bolts

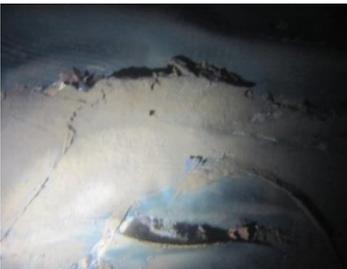
10	Very Poor	<ul style="list-style-type: none"> Failure of plastic liner due to natural ageing Imminent leak from the tank floor

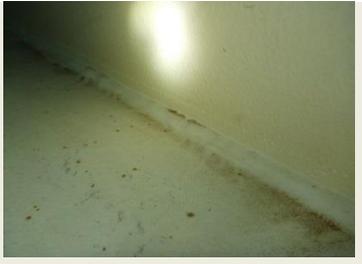
ACA Rating	ACA Outcome	Description	Descriptive Photograph
1 or 2	Excellent	<ul style="list-style-type: none"> No or very minor defects on the floor protective coating

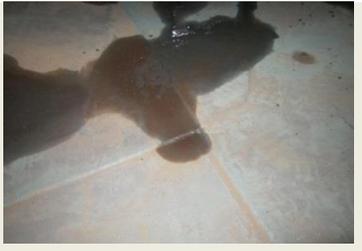
3 or 4	Very Good	<ul style="list-style-type: none"> Moderate deterioration to the floor coating

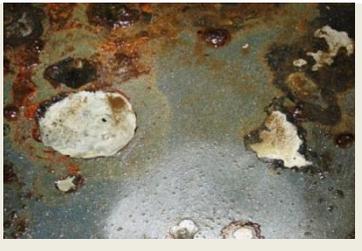
5 or 6	Good	<ul style="list-style-type: none"> Moderate deterioration with signs of coating blisters Upon removal of the protective coating shiny metal can be observed

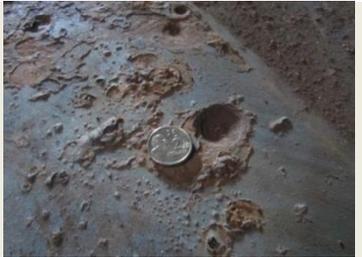
7 or 8	Fair	<ul style="list-style-type: none"> Upon removal of rust, severe localised pitting corrosion (craters) on the tank floor

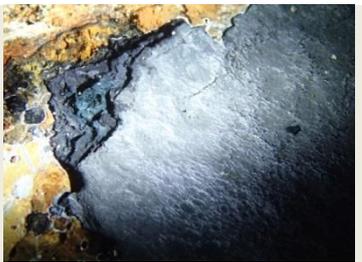
9	Poor	<ul style="list-style-type: none"> Severe corrosion on the floor At times, large pitting corrosion (craters) are observed

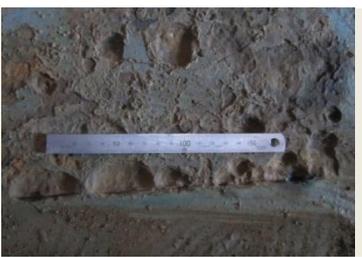
10	Very Poor	<ul style="list-style-type: none"> Clusters of pitting corrosion (craters) on the weld joints, floor and annular plates Imminent leak from the tank floor

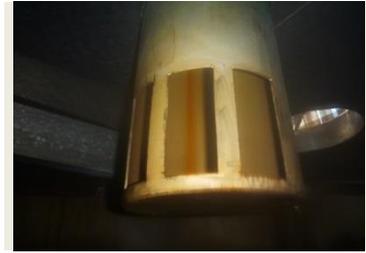
ACA Rating	ACA Outcome	Description	Descriptive Photograph
1 or 2	Excellent	<ul style="list-style-type: none"> No or very minor defects on the inlet pipe

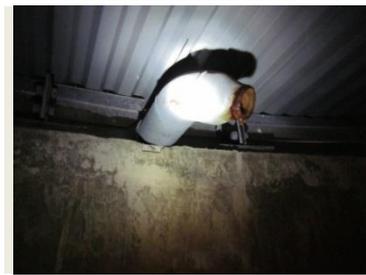
3 or 4	Very Good	<ul style="list-style-type: none"> Moderate deterioration/signs of corrosion to the inlet pipe

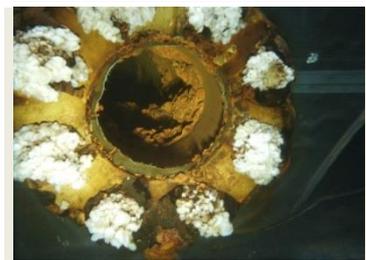
5 or 6	Good	<ul style="list-style-type: none"> Deposition of chloride on the zinc coated bolts Moderate to severe corrosion

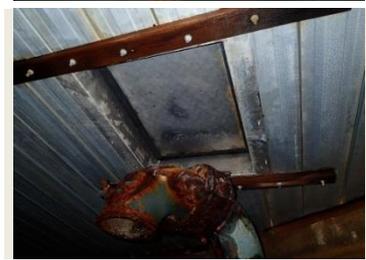
7 or 8	Fair	<ul style="list-style-type: none"> Signs of corrosion on the inlet pipe

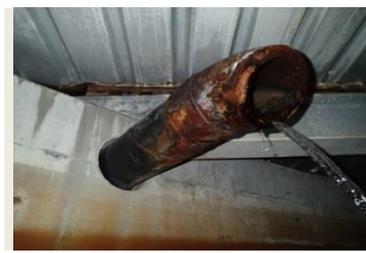
9	Poor	<ul style="list-style-type: none"> Severe corrosion on the inlet pipe

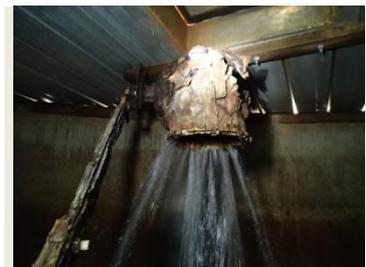
10	Very Poor	<ul style="list-style-type: none"> Severe corrosion on the inlet pipe

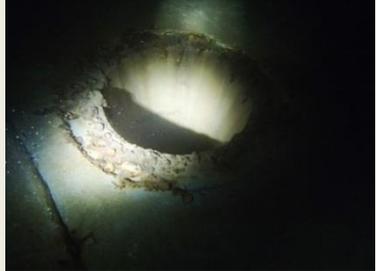
ACA Rating	ACA Outcome	Description	Descriptive Photograph
1 or 2	Excellent	<ul style="list-style-type: none"> No or very minor defects on the scour pipe

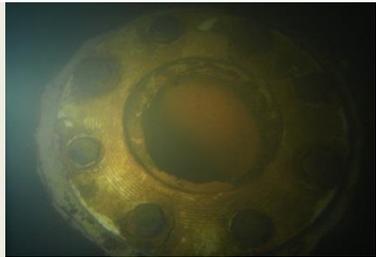
3 or 4	Very Good	<ul style="list-style-type: none"> Moderate deterioration/signs of corrosion to the scour pipe

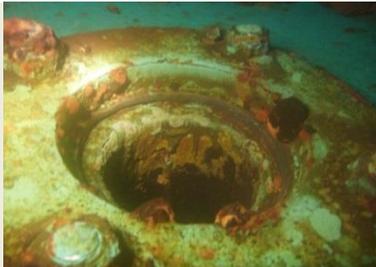
5 or 6	Good	<ul style="list-style-type: none"> Deposition of chloride on the zinc coated bolts Moderate to severe corrosion

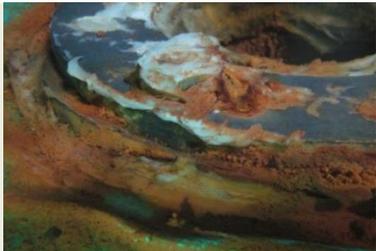
9	Poor	<ul style="list-style-type: none"> Severe corrosion on the scour pipe

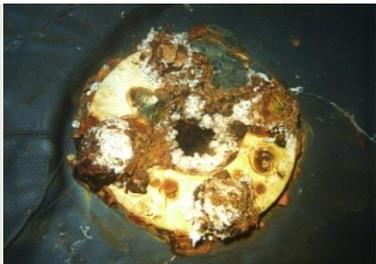
10	Very Poor	<ul style="list-style-type: none"> Severe corrosion on the scour pipe resulting in the blockage of scour pipe.

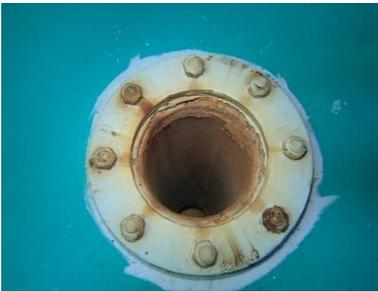
ACA Rating	ACA Outcome	Description	Descriptive Photograph
1 or 2	Excellent	<ul style="list-style-type: none"> No or very minor defects on the outlet pipe

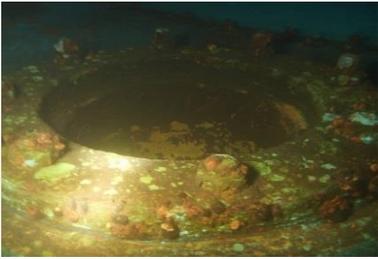
5 or 6	Good	<ul style="list-style-type: none"> Deposition of chloride on the zinc coated bolts Moderate to severe corrosion

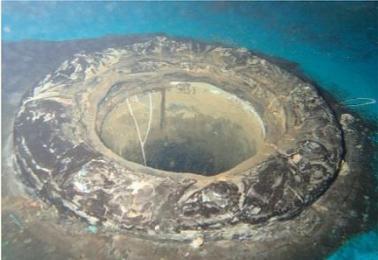
9	Poor	<ul style="list-style-type: none"> Severe corrosion on the outlet pipe

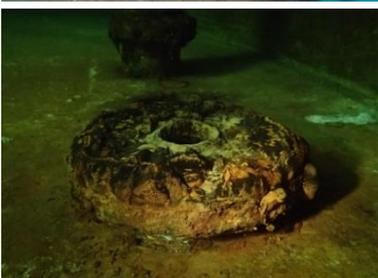
10	Very Poor	<ul style="list-style-type: none"> Severe corrosion on the outlet pipe

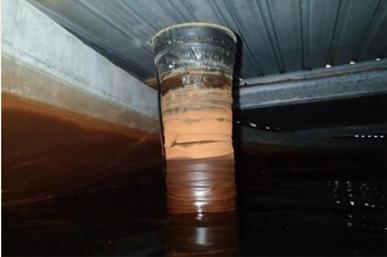
ACA Rating	ACA Outcome	Description	Descriptive Photograph
1 or 2	Excellent	<ul style="list-style-type: none"> No or very minor defects on the overflow pipe

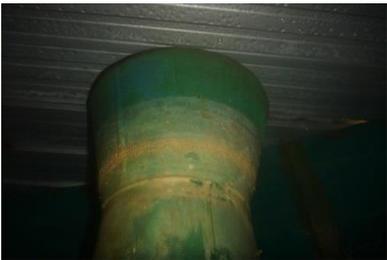
3 or 4	Very Good	<ul style="list-style-type: none"> Moderate deterioration/signs of corrosion to the overflow pipe

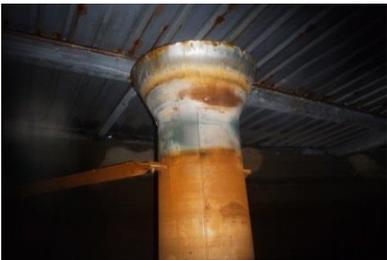
5 or 6	Good	<ul style="list-style-type: none"> Moderate to severe corrosion on the overflow

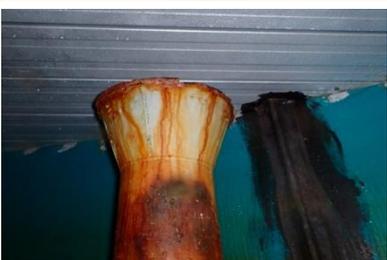
7 or 8	Fair	<ul style="list-style-type: none"> Signs of severe corrosion on the overflow pipe

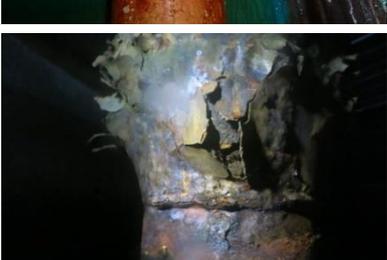
9	Poor	<ul style="list-style-type: none"> Severe corrosion on the bell-mouth of the overflow pipe

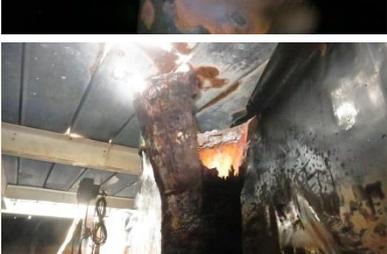
10	Very Poor	<ul style="list-style-type: none"> Failure of the overflow pipe due to sever corrosion/deterioration

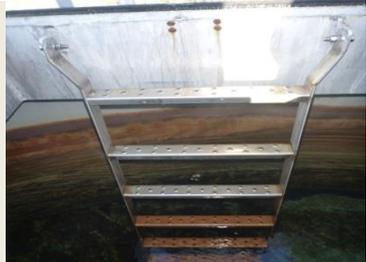
ACA Rating	ACA Outcome	Description	Descriptive Photograph
1 or 2	Excellent	<ul style="list-style-type: none"> No or very minor defects

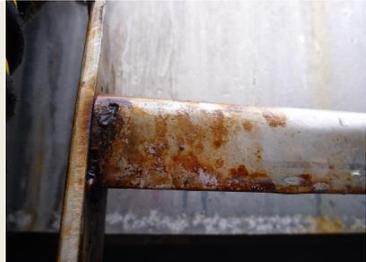
3 or 4	Very Good	<ul style="list-style-type: none"> Minor corrosion/deterioration to the rails and rungs

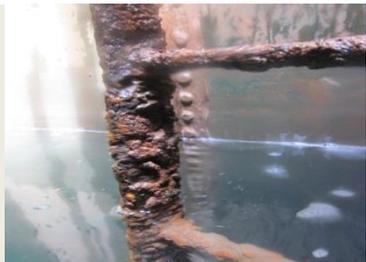
5 or 6	Good	<ul style="list-style-type: none"> Moderate corrosion/deterioration to the ladder rails and rungs Early signs of moderate rust

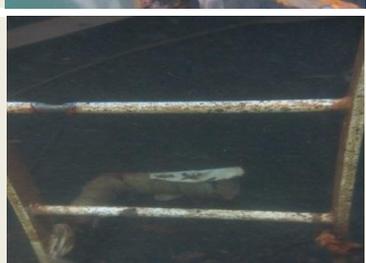
7 or 8	Fair	<ul style="list-style-type: none"> Severe localised corrosion/necking on the ladder rails

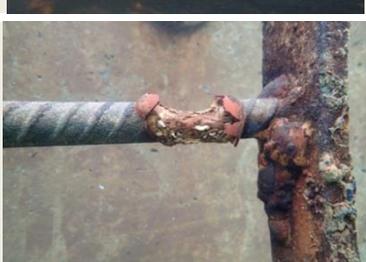
9	Poor	<ul style="list-style-type: none"> Severe localised corrosion/necking on the ladder rails Imminent failure to the ladder
